**NATIONAL DISASTER MANAGEMENT AUTHORITY**

# POST-MONSOON 2026

## ASSESSMENT OF INFRASTRUCTURE DAMAGES & RESILIENCE NEEDS REPORT

**INFRASTRUCTURE ADVISORY  
& PROJECT DEVELOPMENT (IA&PD) WING**

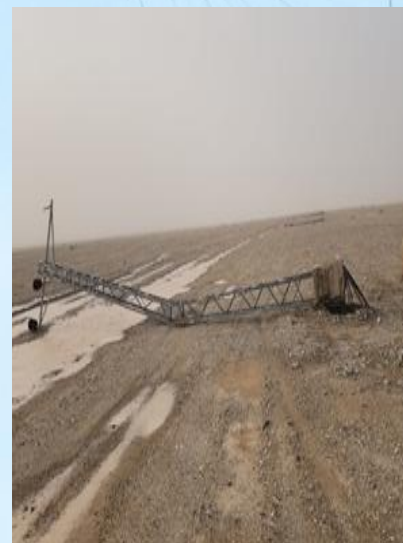
**ASSESSMENT STATUS:** PARTIALLY DAMAGED

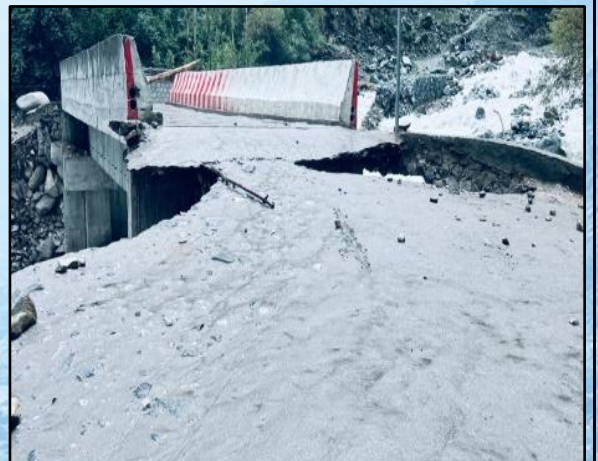
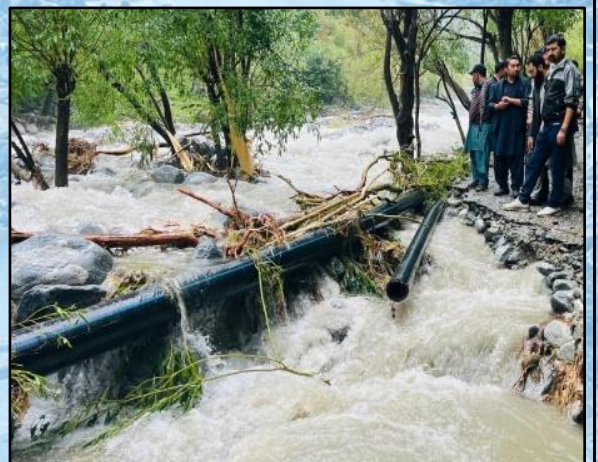
**ASSESSMENT STATUS:** **PARTIALLY DAMAGED – BRIDGE UNDER THREAT**

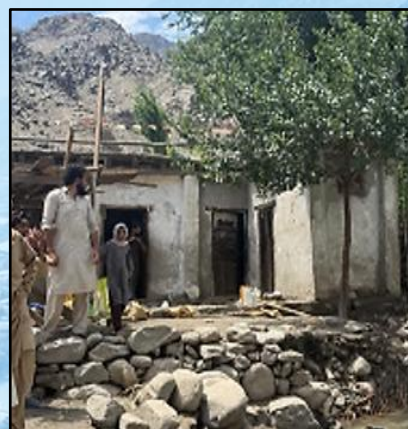
**ASSESSMENT STATUS:** PARTIALLY–FULLY DAMAGED

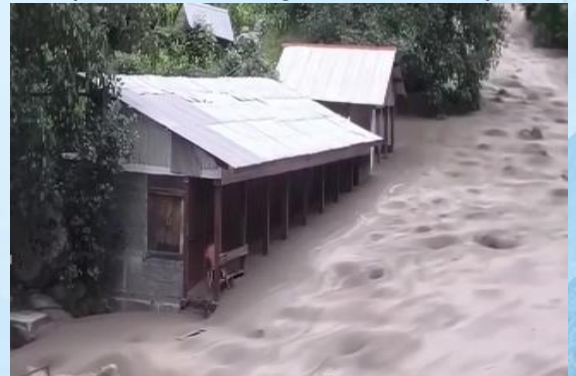
A significant number of residential structures were found to be located in flood-prone zones, particularly along riverbeds, nullahs, and low-lying depressions with inadequate natural drainage. Settlements established in these areas were directly exposed to surface runoff and prolonged inundation during peak monsoon activity. This pattern of unregulated development demonstrates the absence of comprehensive land-use planning and enforcement of zoning regulations at the local level. The high-water table and poor drainage characteristics of these areas led to persistent waterlogging, which severely compromised the load-bearing capacity of foundation soils, eventually resulting in partial or complete structural failures.

*Figure 9: Residential Settlements Located in Flood Prone Areas*

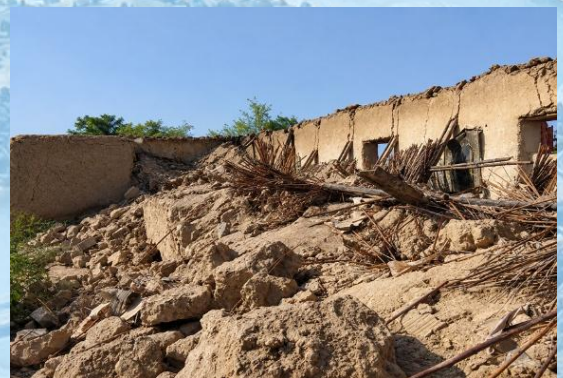
Field investigations indicated that a majority of damaged houses employed shallow foundation systems constructed without consideration of site-specific soil conditions. The lack of geotechnical assessment or engineering supervision led to the use of weak and moisture-sensitive soil strata as bearing layers. Under prolonged saturation, these layers experienced significant loss of shear strength, triggering settlement, tilting, or cracking of superstructures. The absence of proper foundation reinforcement and inadequate footing depth, particularly in single-storey masonry dwellings, amplified vulnerability during sustained monsoon events.

*Figure 10: Flood Affecting Residential Structures (Inadequate Foundation Design)*

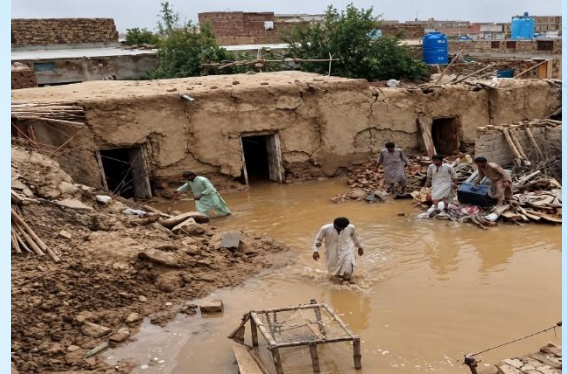
Prolonged floodwater exposure and unlined drainage channels caused progressive scouring and erosion of foundation soils. Houses situated near watercourses or along eroded embankments were especially prone to foundation soil erosion, where the removal of subsoil beneath the structure led to partial collapse. This phenomenon was prevalent in both urban fringe settlements and rural communities where drainage systems remain underdeveloped. Such erosion not only undermined the stability of the foundations but also induced tilting and separation of structural elements, rendering the buildings unsafe for habitation even after floodwaters receded.

*Figure 11: Foundation soil erosion and scouring causing structural instability during monsoon flooding.*

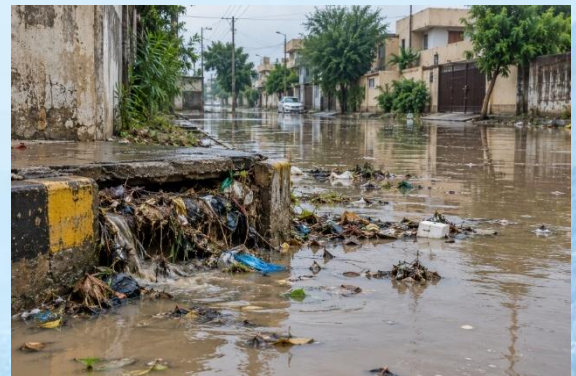
Inadequate surface and sub-surface drainage infrastructure emerged as another major cause of structural failure. Blocked or undersized drains, combined with poor site grading, resulted in the accumulation of standing water around building perimeters. Continuous waterlogging accelerated the degradation of foundations, facilitated seepage through walls, and weakened structural joints. The problem was further intensified by debris accumulation, lack of maintenance, and unplanned urban extensions that obstructed natural water paths. The assessment emphasizes that ensuring effective stormwater drainage systems at both community and household levels is critical to reducing future damage potential.

*Figure 12: Blocked drainage causing severe urban waterlogging during monsoon rainfall.*

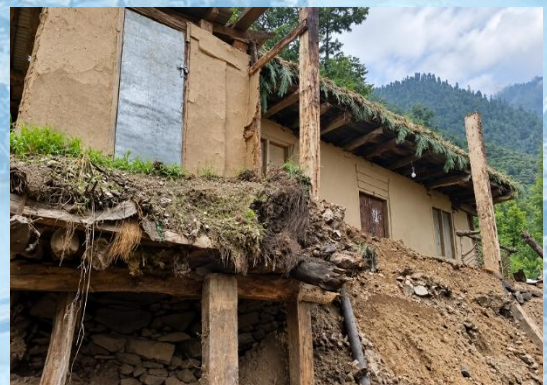
Several affected areas experienced significant ground movement due to saturation-induced slope instability, particularly in hilly and mountainous terrain. This movement often led to horizontal displacement and settlement of residential structures. Differential settlement, caused by uneven soil consolidation beneath foundations, resulted in visible cracking, tilting, and in some cases, partial collapse of houses. These issues underline the necessity of incorporating geotechnical studies and slope-stability assessments into future construction planning.

*Figure 13: Ground movement and differential settlement causing severe cracking, tilting, and partial collapse of a hillside residential structure.*

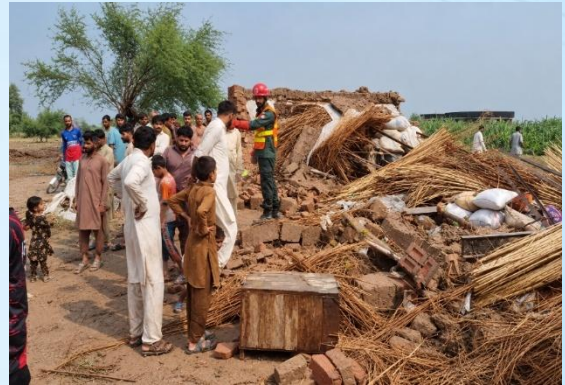
A recurring theme in the field observations was the widespread use of low-quality, non-engineered materials. Many rural and peri-urban houses were constructed using unreinforced brick masonry, mud mortar, or loosely compacted earthen blocks. Such materials lack the tensile strength and water resistance required to endure prolonged exposure to moisture and hydraulic pressure. As a result, structural elements deteriorated rapidly when subjected to sustained rainfall and flooding. Cracking, spalling, and joint failures were commonly observed, rendering structures non-repairable in many cases. The absence of standardized building codes, limited technical oversight, and cost-driven shortcuts further exacerbated this condition.

*Figure 14: Flood-damaged house constructed with substandard masonry materials, showing severe wall deterioration and fully collapse.*

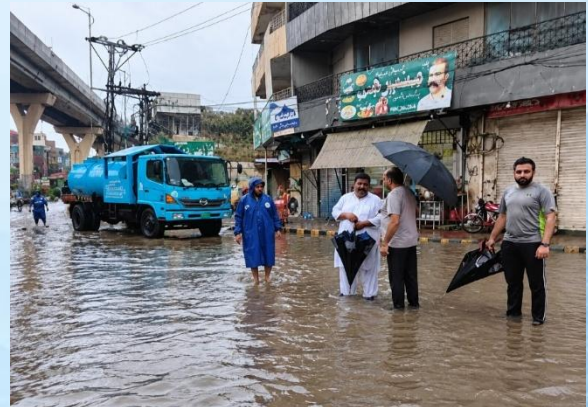
The absence of functional storm water drainage systems around residential settlements was a primary factor contributing to building damage. Without adequate channels for runoff, rainwater accumulated around structures, resulting in ponding and hydrostatic pressure against walls. Continuous seepage into foundations weakened building bases and caused cracking in structural elements.

*Figure 15: Prolonged waterlogging around structures due to inadequate stormwater drainage during monsoon flooding.*

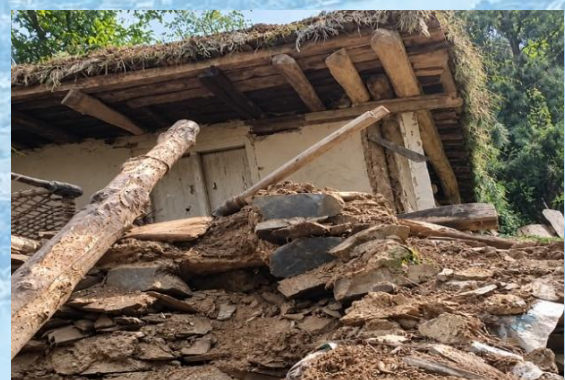
Sustained rainfall led to high soil saturation, significantly reducing the ground's bearing capacity. The softened subsoil beneath foundations caused differential settlement, leading to wall cracking and in some cases partial collapse of structures. Houses built on soft alluvial soils or un-engineered fill were especially prone to such settlement-related failures during the monsoon period.

*Figure 16: Soil settlement causing foundation displacement, severe wall cracking, and partial structural collapse during monsoon flooding.*

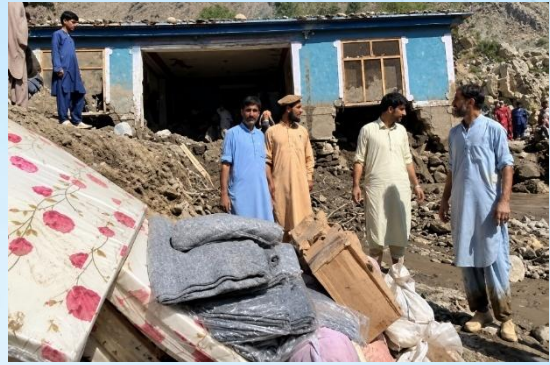
Unregulated construction along natural drainage paths and floodplains exacerbated flood impacts. These encroachments obstructed natural water flow, creating backflow and concentrated hydraulic pressure against residential structures. The diversion of runoff into populated areas intensified erosion and flooding, leading to greater structural damage and foundation instability.

*Figure 17: Residential damage intensified by encroachment on natural waterways*

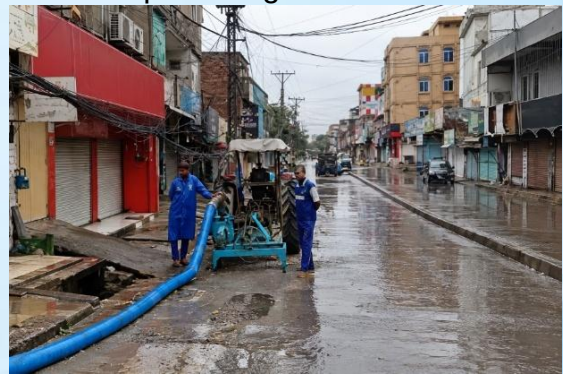
Improper drainage planning, including insufficient slope design and lack of runoff management channels, allowed storm water to stagnate near building foundations. The resulting prolonged exposure to moisture caused wall seepage, material deterioration, and weakening of substructures. Many settlements lacked coordinated municipal drainage layouts, further amplifying local flooding effects.

*Figure 18: Inadequate drainage planning causing prolonged waterlogging around residential structures during monsoon rainfall.*

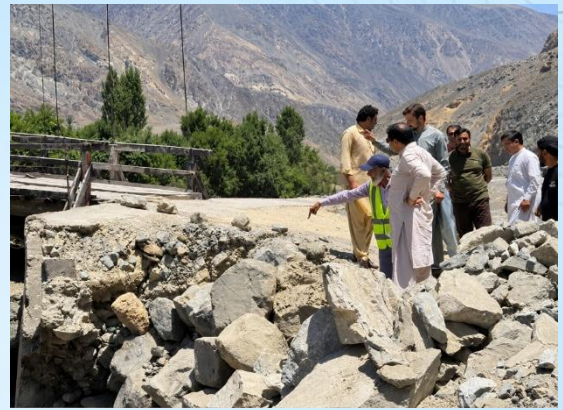
Figure 20: Bridge failure and structural distress under high-velocity flood flows.

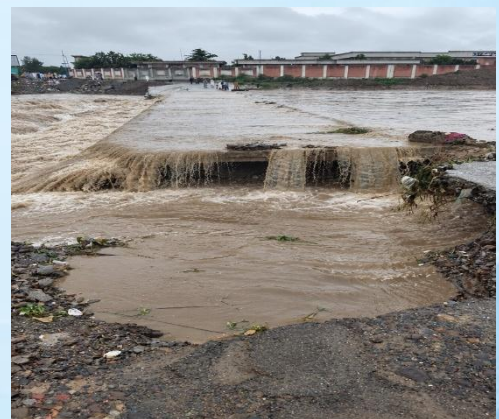
Figure 21: Undersized and debris-choked culvert causing overtopping, road inundation, and embankment erosion

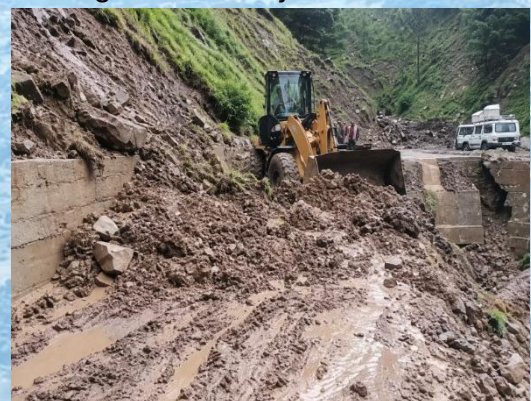
Figure 22: Slope instability causing road embankment failure and landslide damage during heavy monsoon rainfall.

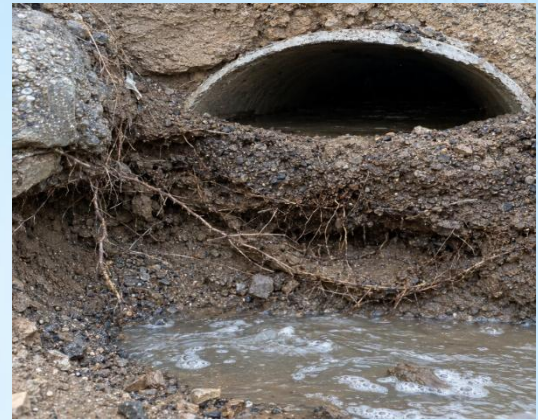
Figure 23: Sediment and debris accumulation clogging culvert openings and obstructing floodwater flow.

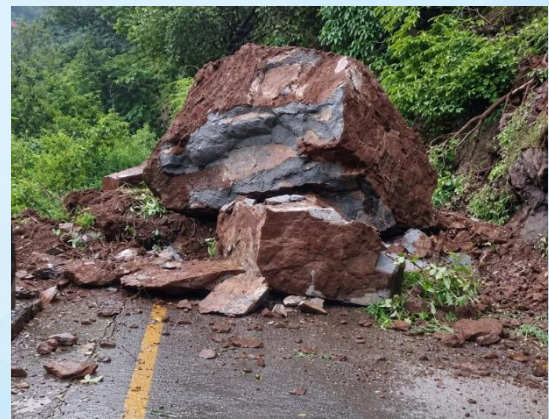
Figure 24: Soil erosion and landslide debris causing road embankment failure and disrupting connectivity during monsoon rainfall.

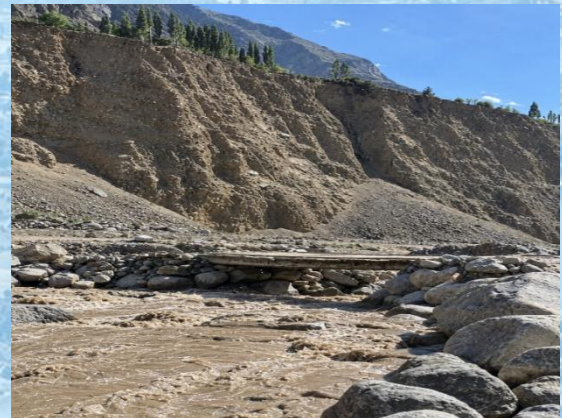
Figure 25: Aging bridge infrastructure showing severe deterioration and vulnerability to monsoon flood flows.

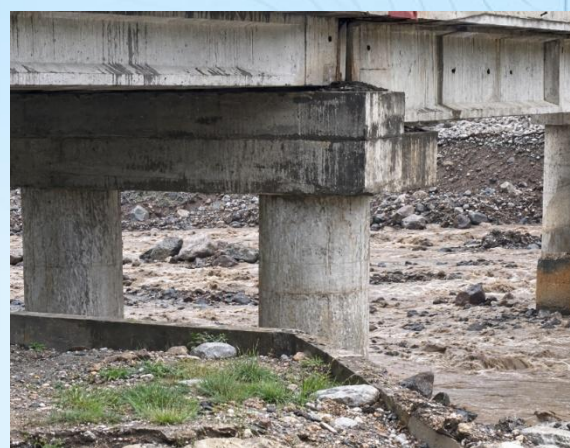
Figure 26: Bridge foundation Vulnerability due to unregulated sand & gravel mining
