**National Disaster
Management
Authority**

Assessment of Infrastructure Failures & Resilience Needs

POST-MONSOON 2025

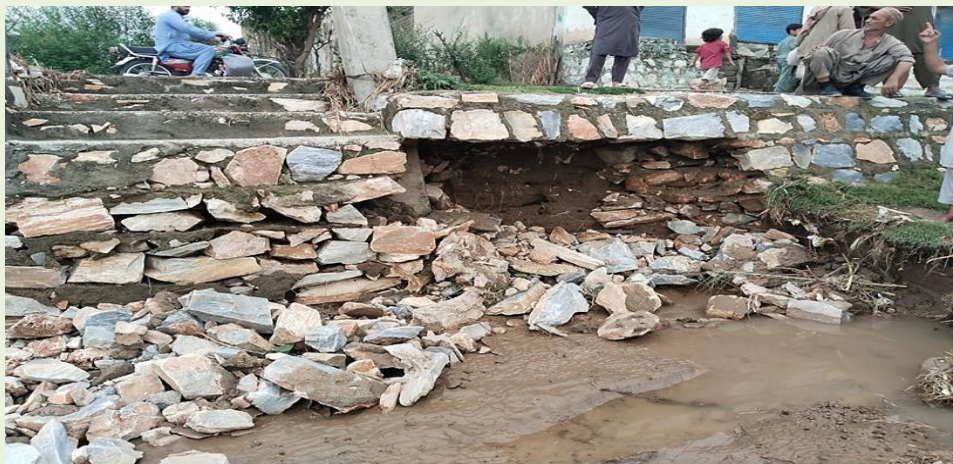
A flash flooding event struck parts of Swabi District, resulting in significant deterioration of binding materials and erosion at infrastructure bases. The forceful water flow eroded the supporting soil around small retaining walls and culverts, destabilizing foundations and threatening adjacent structures.

Figure 3: Structural Erosion and Material Degradation in Swabi Following Flash Flood

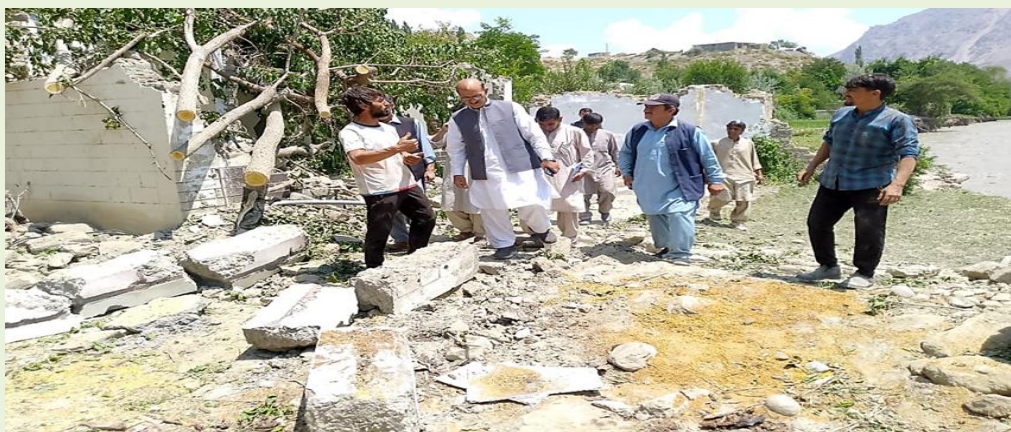
In Chitral District, intense flash floods led to house collapse and uprooting of trees, accompanied by extensive water seepage into residential structures. This incident highlighted the compounded effects of flash flooding in mountainous settlements.

Figure 4: Ground Instability and Vegetation Uprooting in Chitral

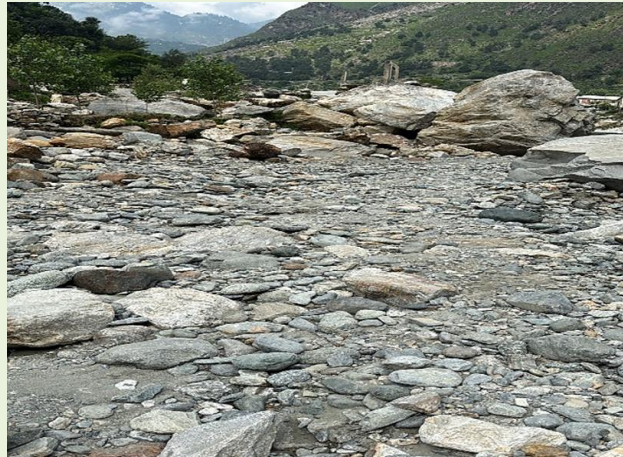
A major landslide in Lower Kohistan caused road blockages along key inter-district routes. The event was attributed to slope instability induced by persistent rainfall and loose geological formations. This incident underscores the vulnerability of the province's mountainous road infrastructure to recurring monsoon-induced landslides.

Figure 5: Rainfall-Induced Slope Instability and Road Blockage in Lower Kohistan

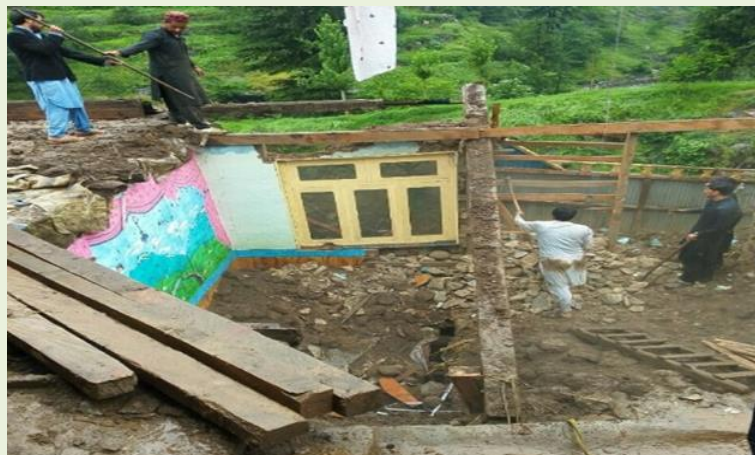
In Mansehra District, excessive rainfall led to water accumulation on rooftops, triggering structural failure and roof collapse in several houses. The incident reinforced the need for improved roofing materials and drainage systems, particularly in semi-urban and rural areas with non-engineered construction practices.

Figure 6: Roof Collapse Due to Rainwater Accumulation

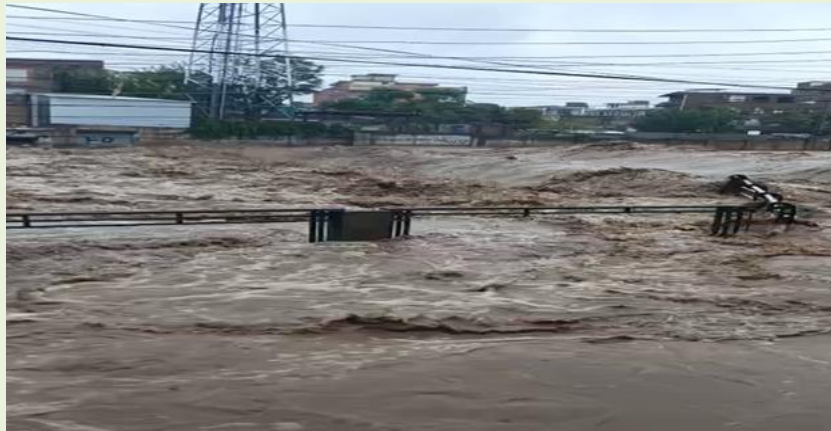
Heavy monsoon downpours in Swat District caused a flash flood, leading to extensive road blockages and the submergence of low-lying areas. The event exposed the lack of adequate drainage systems, as accumulated runoff overwhelmed local channels and roadways. This disrupted vehicular movement and isolated several adjoining communities.

Figure 7: Severe Urban Flooding Due to Inadequate Drainage Infrastructure

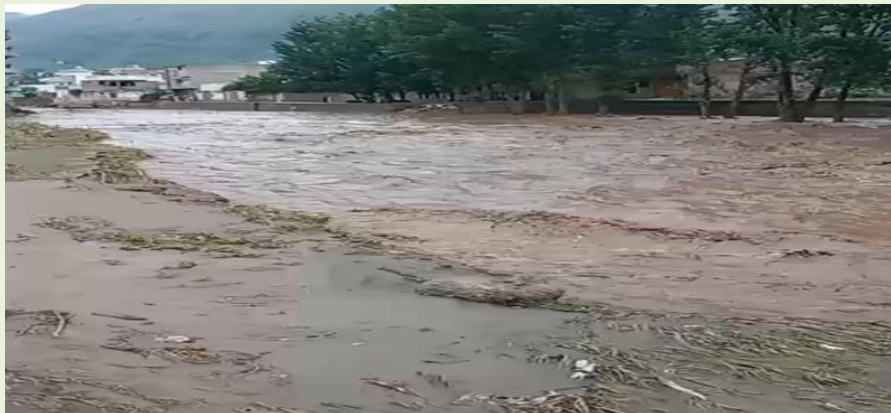
Just days later, another flood event on 18th August 2025 in Swat resulted in severe road erosion due to soil saturation and instability. Prolonged waterlogging weakened the road base, leading to partial collapses and posing hazards for transport and relief operations. This recurrence underscored the persistent threat of slope and soil failures in the northern highlands during sustained rainfall.

Figure 8: Flash Flood-Induced Inundation Due to Inadequate Urban Drainage

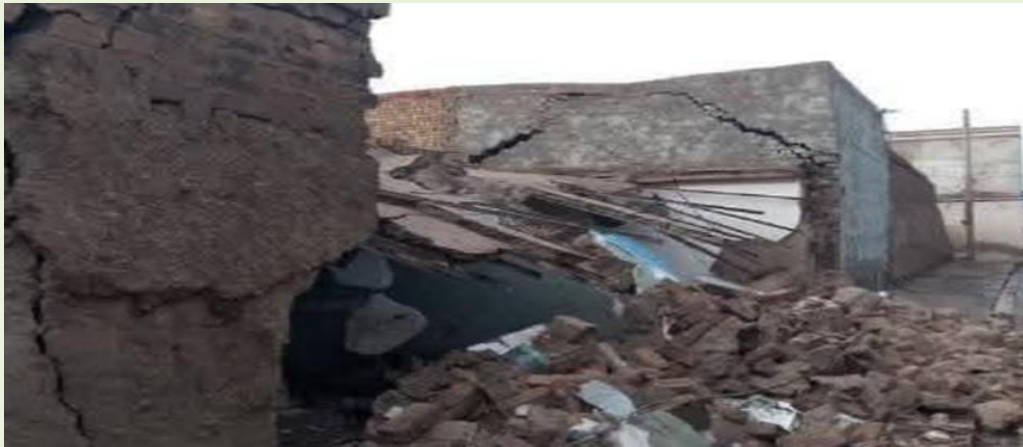
In Dera Ismail Khan, intense rainfall led to the collapse of multiple houses, revealing major concerns regarding structural integrity in vulnerable settlements. The incident caused displacement of affected households and significant property losses.

Figure 9: Structural Collapse of Houses

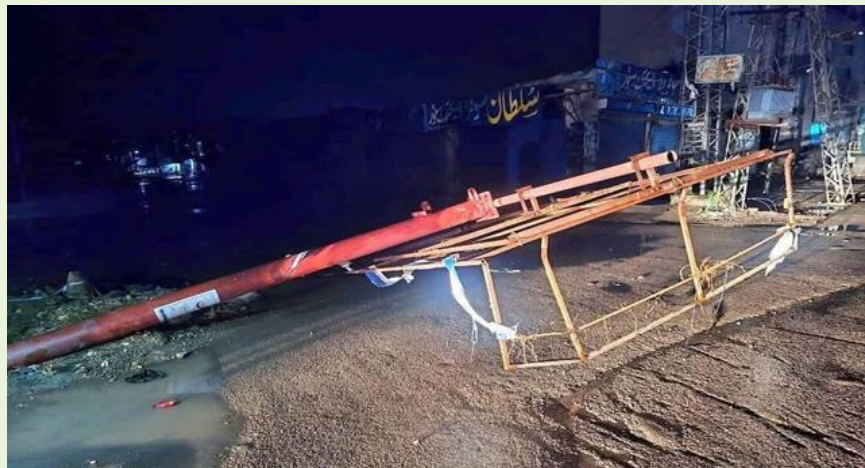
Concurrent to the heavy rains, strong winds toppled electrical poles, leading to temporary power outages in several urban and semi-urban areas. The damage was linked to the lack of bracing and structural reinforcement in electrical infrastructure, further emphasizing the cascading impact of monsoon-induced weather conditions on critical lifelines.

Figure 10: Failure of Unbraced Electrical Pole Infrastructure

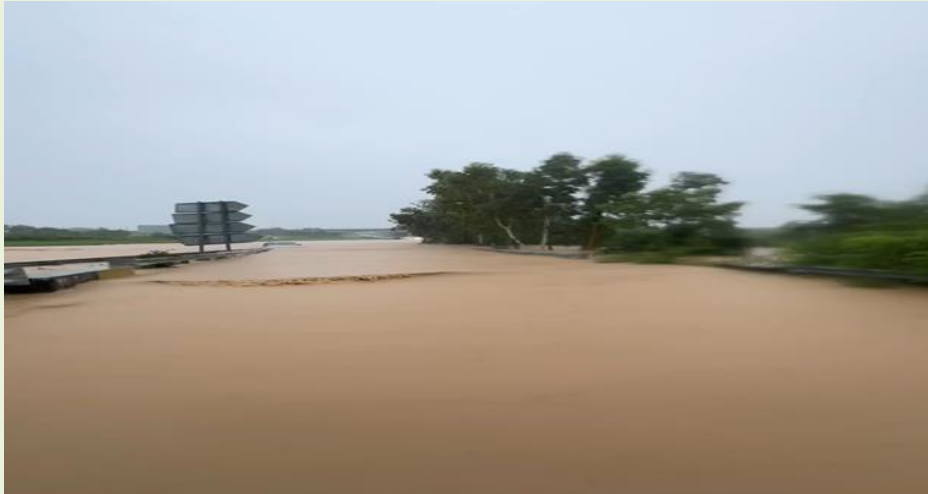
identified as the blockage of the drainage network, which prevented effective runoff management. This event underscores the urgent need for routine maintenance and regular desilting of stormwater channels along major transport corridors.

Figure 12: Flooding and Water Accumulation on Motorway Due to Blocked Drainage Network

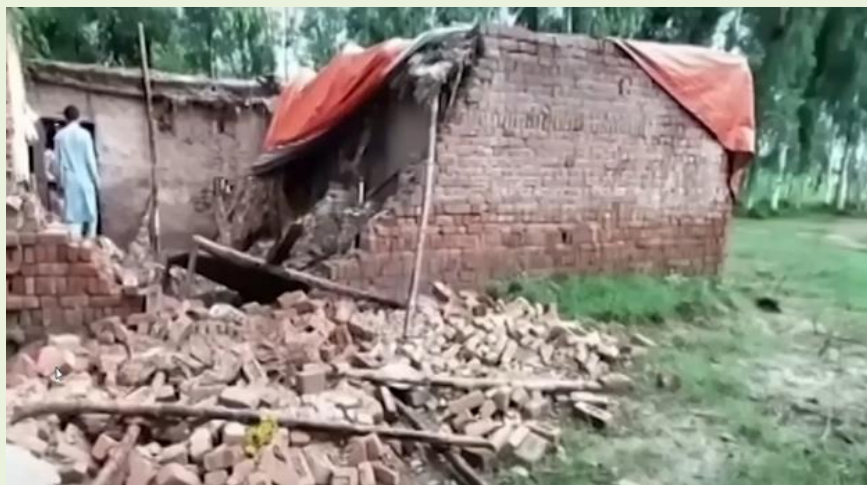
In Sargodha, continuous rainfall caused the collapse of residential structures, revealing critical weaknesses in local construction practices. The use of substandard building materials and the lack of proper reinforcement were major contributing factors. These findings call for stricter enforcement of building codes and quality control measures, particularly in flood-prone rural settlements.

Figure 13: Structural Collapse of Residential Houses in Sargodha Due to Poor Construction Practices

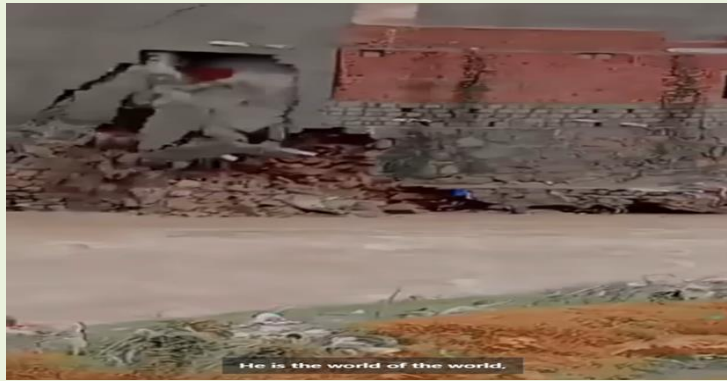
In Rawalpindi, flooding led to the collapse of a residential house, primarily due to foundation settlement and soil erosion. The incident highlights the vulnerability of low-lying urban areas where unplanned drainage and weak soil conditions exacerbate the effects of heavy rainfall. Improved geotechnical assessment and flood-resilient construction practices are required to mitigate similar future losses.

Figure 14: Structural Failure of Residential Building Due to Foundation Settlement and Erosion

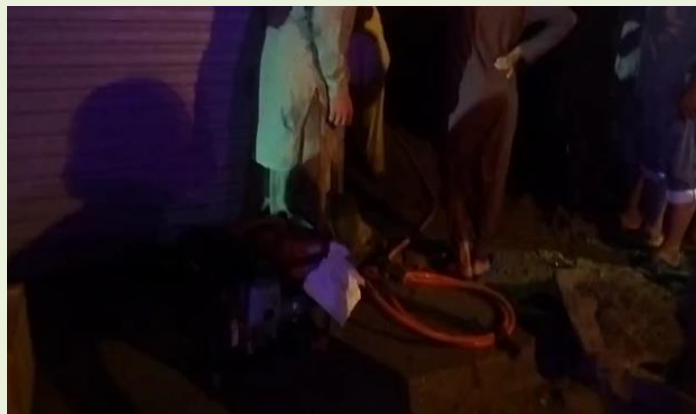
In Muzaffargarh, intense rainfall caused the collapse of a roof, attributed to water ponding and insufficient roof drainage systems. The event reveals the recurring issue of poor design and maintenance in residential roofing structures. Incorporating roof slope standards, effective drainage outlets, and regular inspections could significantly reduce such risks.

Figure 15: Roof Collapse in Muzaffargarh Due to Water Ponding and Inadequate Drainage

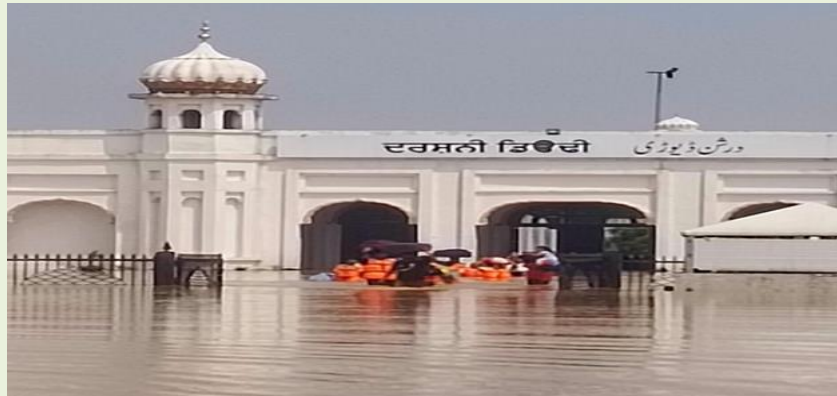
The Kartarpur Corridor in Narowal experienced severe flooding as a result of poor drainage design and insufficient runoff management. The inundation affected access routes and religious infrastructure, hampering mobility and emergency response. The event emphasizes the necessity for incorporating hydrological assessments and flood-proof design features in sensitive and high-footfall public facilities.

Figure 16: Flooding at Kartarpur Corridor, Narowal Due to Inadequate Drainage Infrastructure

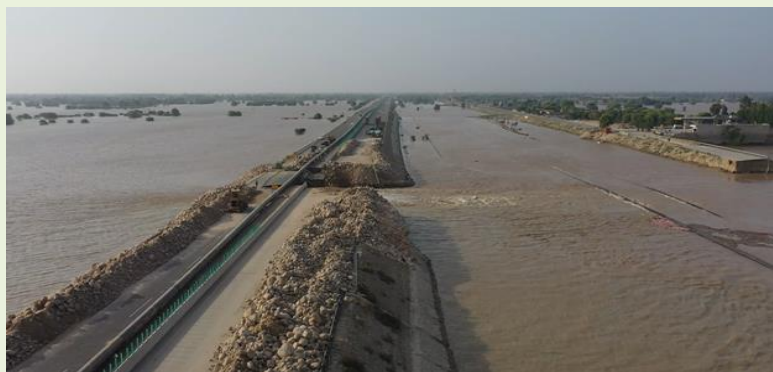
One of the most significant infrastructural failures occurred along the M-5 Multan Motorway, where intense flooding resulted in road erosion and partial collapse of the motorway embankment. The incident revealed underlying vulnerabilities linked to inadequate slope protection, soil compaction issues, and weak embankment stabilization. The scale of damage disrupted inter-district connectivity and underscored the urgent requirement for engineering interventions such as reinforced retaining structures, improved drainage outlets, and flood-resilient pavement materials.

Figure 17: Flood-Induced Erosion and Embankment Collapse on M-5 Motorway, Multan

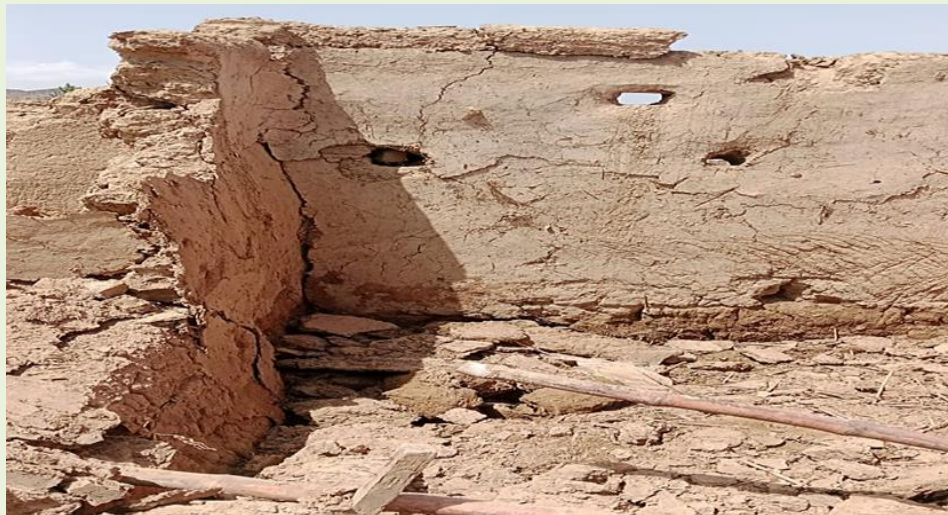
In Musakhail, intense and sustained rainfall on 24th August 2025 resulted in the complete collapse of one residential unit and partial structural damages to more than 30 adjoining houses. The affected structures predominantly comprised earthen and unreinforced masonry materials with inadequate foundations and poor load-bearing capacity. Prolonged moisture infiltration led to the weakening of wall integrity and subsequent localized failures. The incident highlights the high vulnerability of non-engineered construction to hydro-meteorological stresses and reinforces the necessity for promoting resilient building practices, proper drainage planning, and structural reinforcement in flood-prone rural settlements.

Figure 19: House Damage in Musakhail due to Intense Rainfall

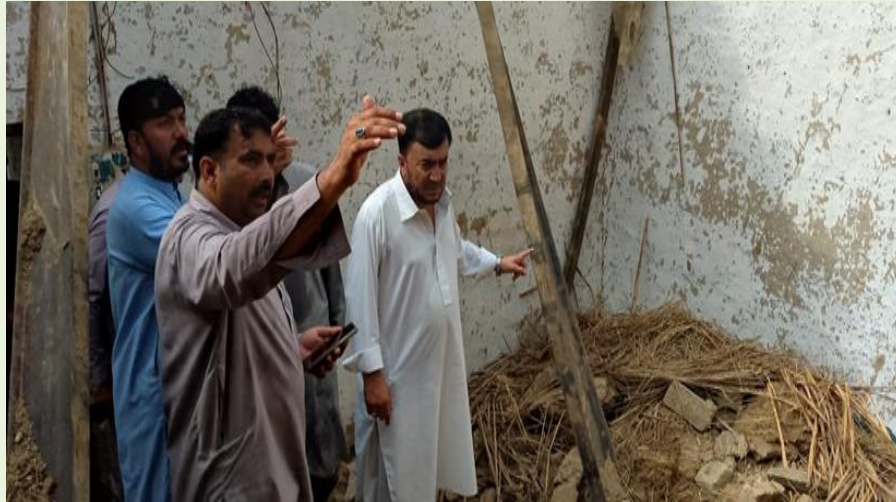
In Harnai, intense rainfall on 18th August 2025 caused the collapse of a residential roof structure. The failure occurred primarily due to the saturation of mud-based roofing materials and the absence of adequate load distribution supports. Field inspection indicated that excessive moisture penetration led to the disintegration of binding materials and subsequent collapse under self-weight. The incident underscores the structural vulnerability of non-engineered housing units to heavy precipitation events and emphasizes the urgent requirement for introducing reinforced roofing systems, improved drainage around foundations, and adherence to resilient construction standards in rural settlements.

Figure 20: Roof Collapse in Harnai due to Intense Rainfall

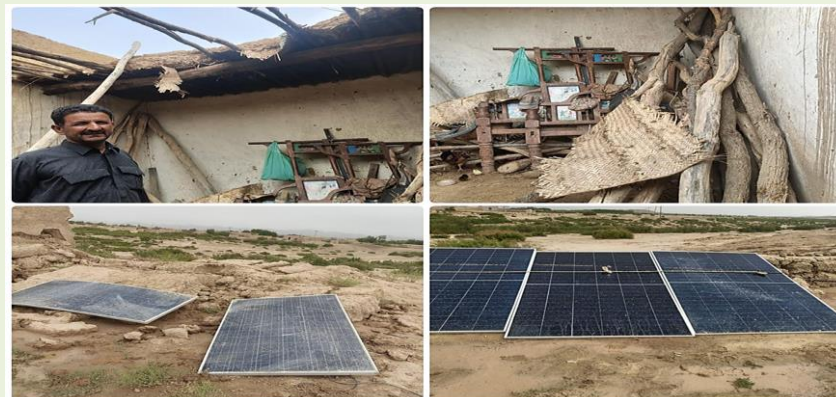
In Surab, a windstorm accompanied by heavy rainfall on 6th July 2025 caused the collapse of residential roof structures and significant damage to solar energy installations. The affected buildings were primarily non-engineered, utilizing wooden trusses and mud plaster, which failed under combined wind pressure and moisture ingress. Several rooftop solar panels and ground-mounted photovoltaic units were dislodged or tilted due to inadequate anchoring and soil erosion around foundations. The incident illustrates the compounded vulnerability of both traditional housing and renewable energy infrastructure to extreme weather conditions, emphasizing the requirement for improved structural anchorage, wind-resistant roofing systems, and climate-resilient solar installations in hazard-prone regions.

Figure 21: Roof and Solar Infrastructure Damage in Surab due to Heavy Rainfall

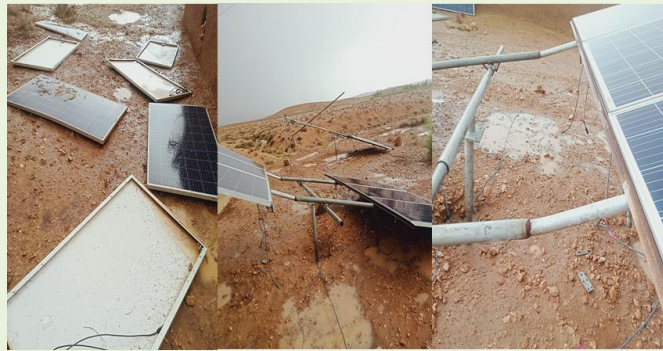
In Surab, heavy rainfall on 9th July 2025 caused extensive damage to solar power infrastructure installed in exposed terrain. Several photovoltaic (PV) panels were displaced, detached, or structurally compromised due to inadequate mounting strength, poor anchoring systems, and soil erosion around support frames. Continuous surface runoff and water accumulation weakened the base stability of steel structures, leading to tilting and mechanical failure of the mounting assemblies.

Figure 22: Solar Infrastructure Damage due to Heavy Rainfall

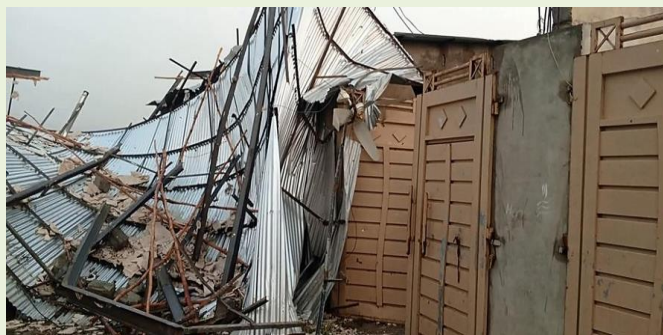
Figure 23: Roof Collapse in Muslim Bagh due to Heavy Rainfall

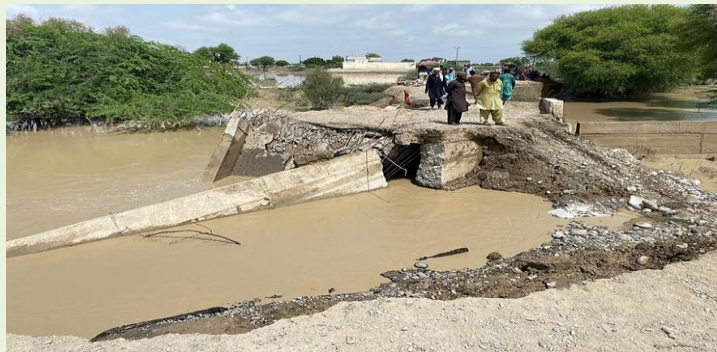
Figure 24: Bridge Washed Away in Lasbela due to Severe Flashflood

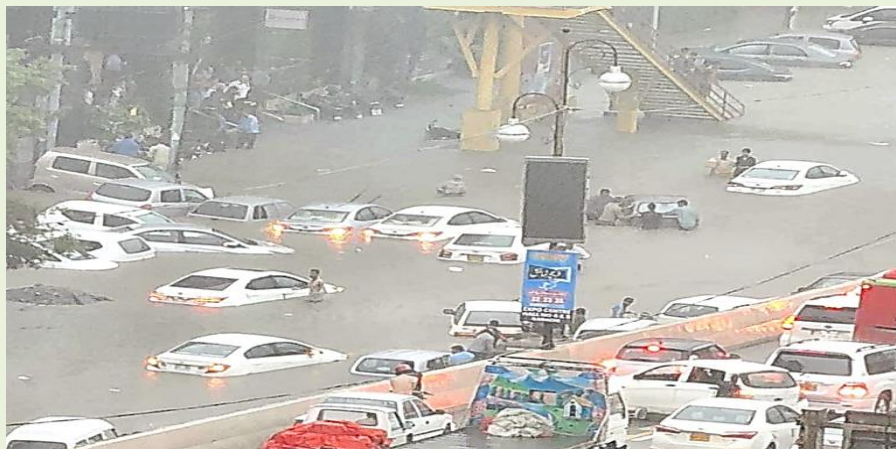
Figure 26: Urban Flooding in Karachi due to Intense and Prolonged Rainfall

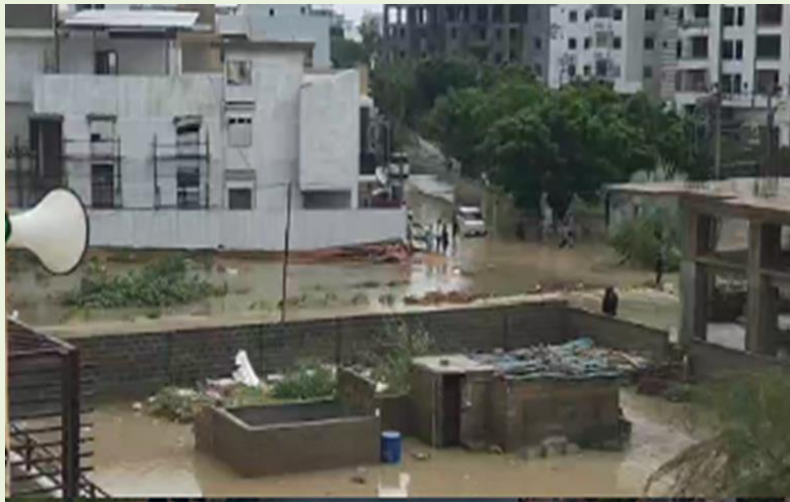
Figure 27: Building Collapse in Karachi due to Heavy and Persistent Rainfall

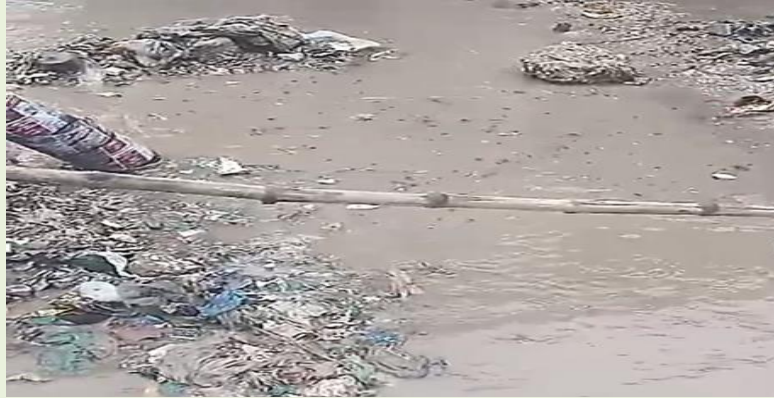
Figure 28: Water Ponding in Sukkur due to Heavy Rainfall

of solid waste disposal regulations, and the integration of climate-resilient stormwater management strategies in city planning to reduce future flood risks.

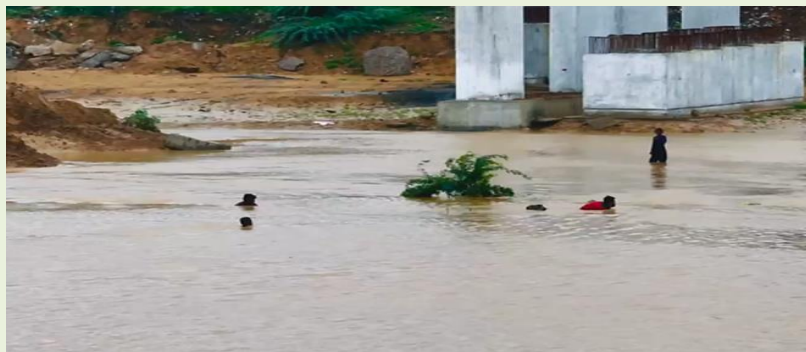
Figure 29: Urban Flooding in Malir, Karachi due to Intense Monsoon Rainfall

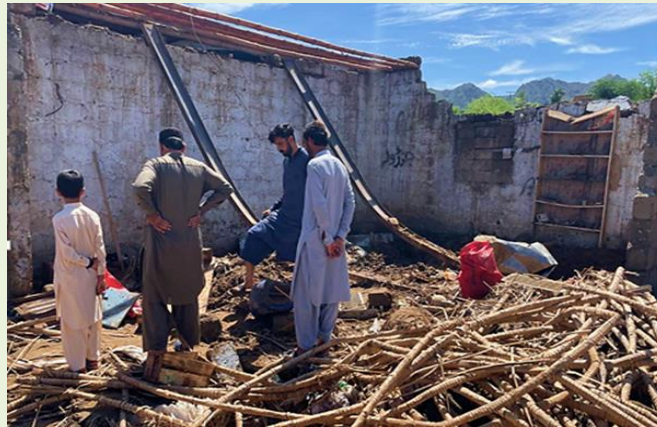
Figure 30: Roof Collapse in Lyari, Karachi due to Heavy Rainfall

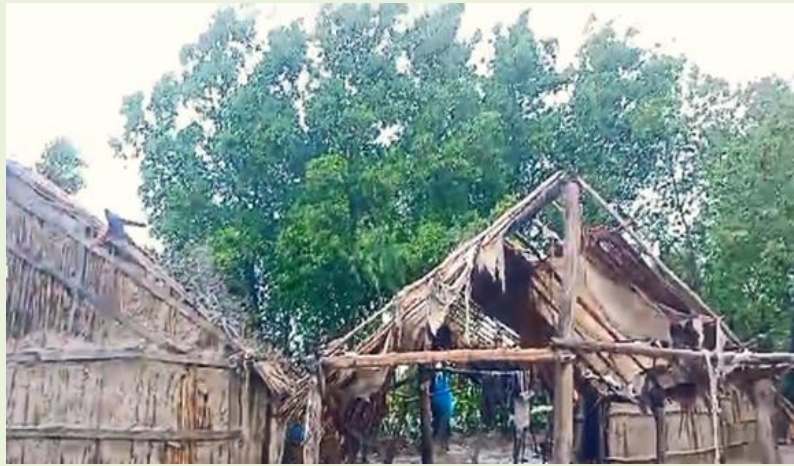
Figure 31: Mud and Thatch House Damage due to Flash Flooding Triggered by Intense Monsoon Rainfall

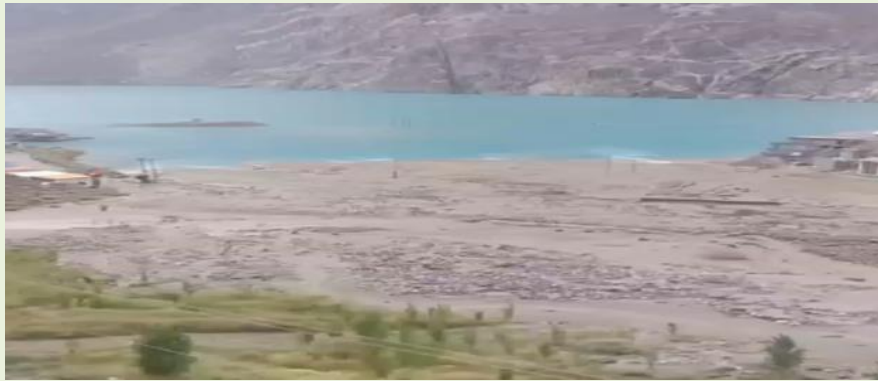
Figure 33: Road Damage at Brundubar Nullah, Hunza – Result of Inadequate Design

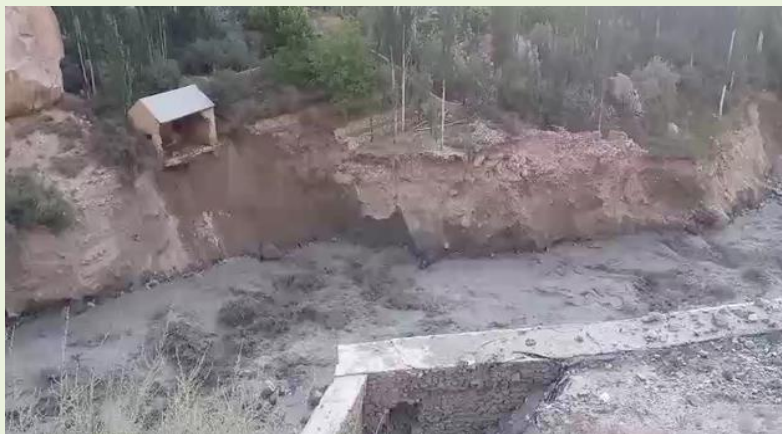
Figure 34: Riverbank Erosion and Slope Failure at Shishper Following GLOF Event

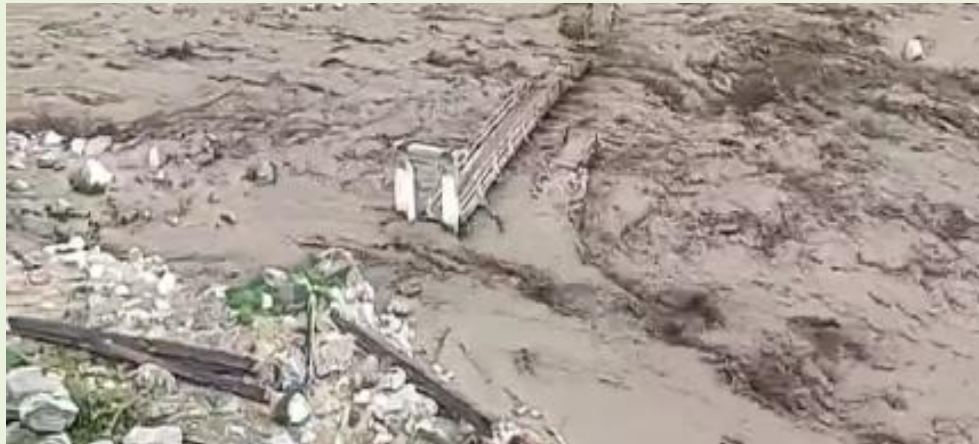
Figure 35: Bridge Collapse at Babusar–Chilas Following Cloud Burst

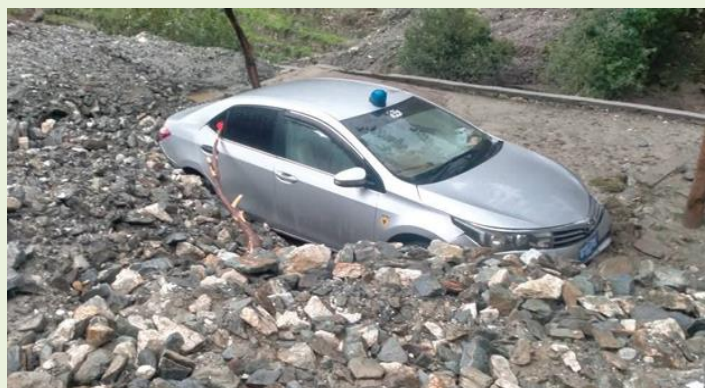
Figure 36: Rainfall-Induced Landslide and Infrastructure Damage at Babusar–Chilas

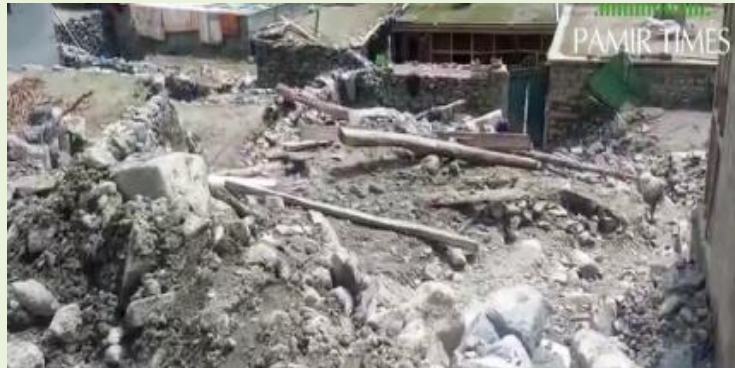
Figure 37: Structural Collapse of Residential Houses in Gilgit Following Flash Flood

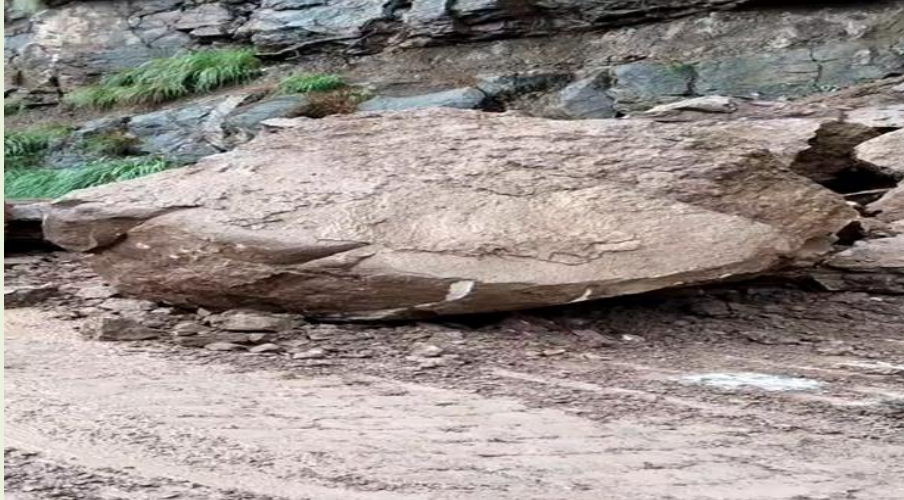
Figure 39: Landslide-Induced Road Blockage in Pallandri Due to Unstable Rocky Slopes

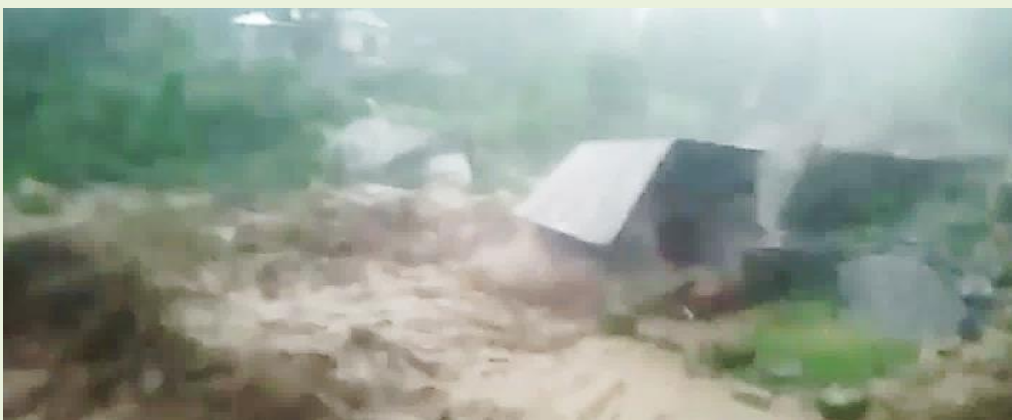
Figure 40: Flash Flood Impact in Neelum Due to Construction within Floodplain Areas

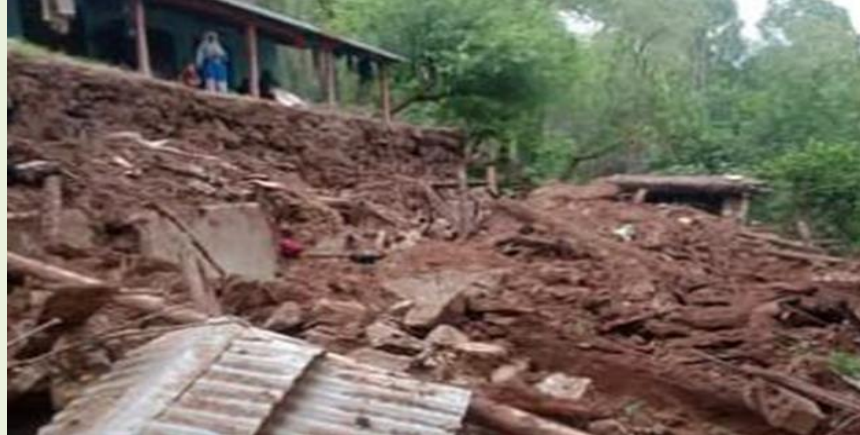
Figure 41: Structural Collapse of Residential Buildings in Sudhnoti Due to Weak Design and Materials

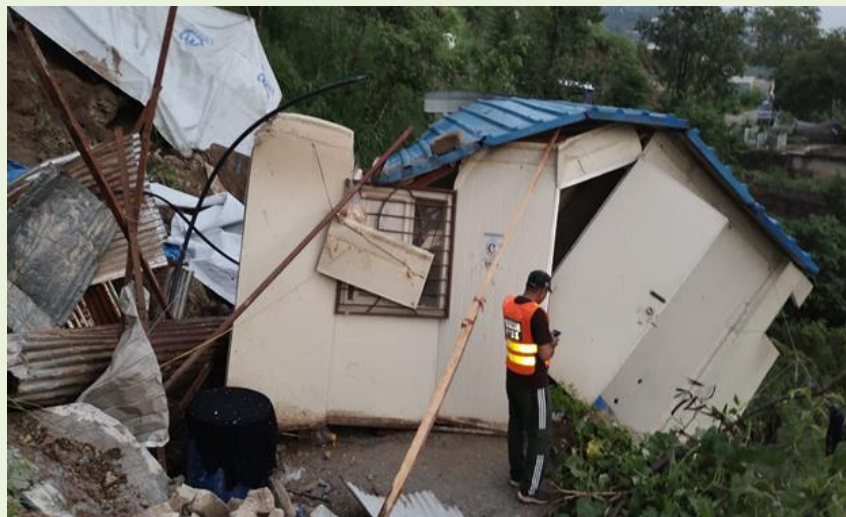
Figure 42: Structural Collapse of a Residential Unit in Muzaffarabad Due to Poor Site Selection

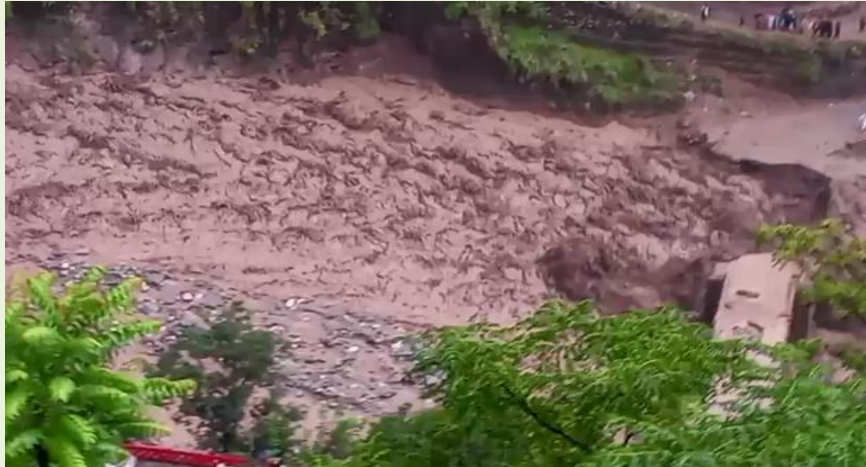
Figure 43: Bridge Collapse in Neelum Due to Flood-Induced Structural Failure

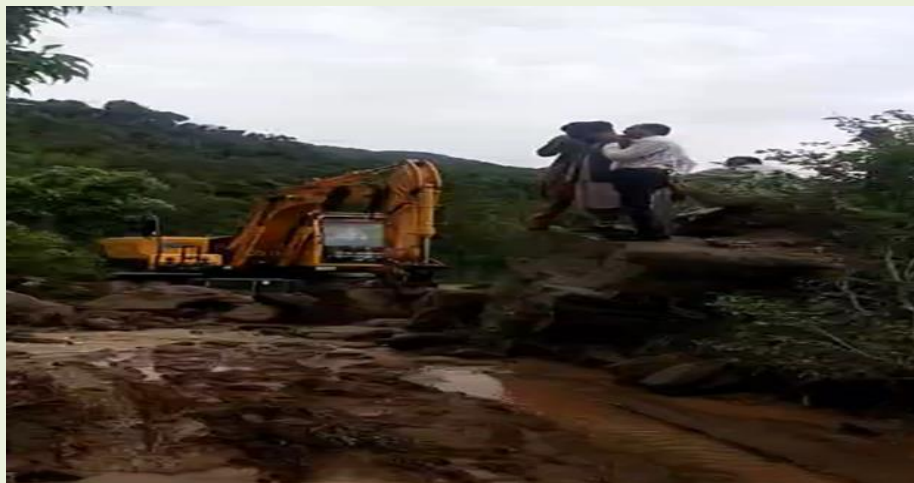
Figure 44: Landslide in Sudhnoti Triggered by Heavy Rainfall and Absence of Retaining Structures

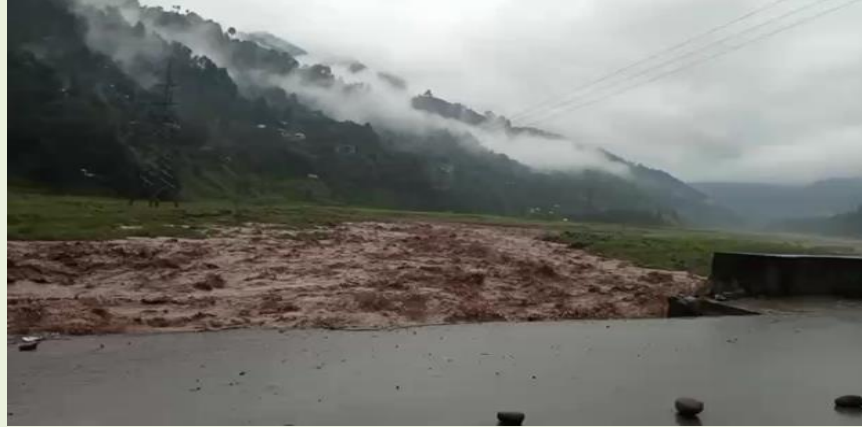
Figure 45: Road and Riverbank Erosion in Bagh Due to Absence of Stabilization Measures

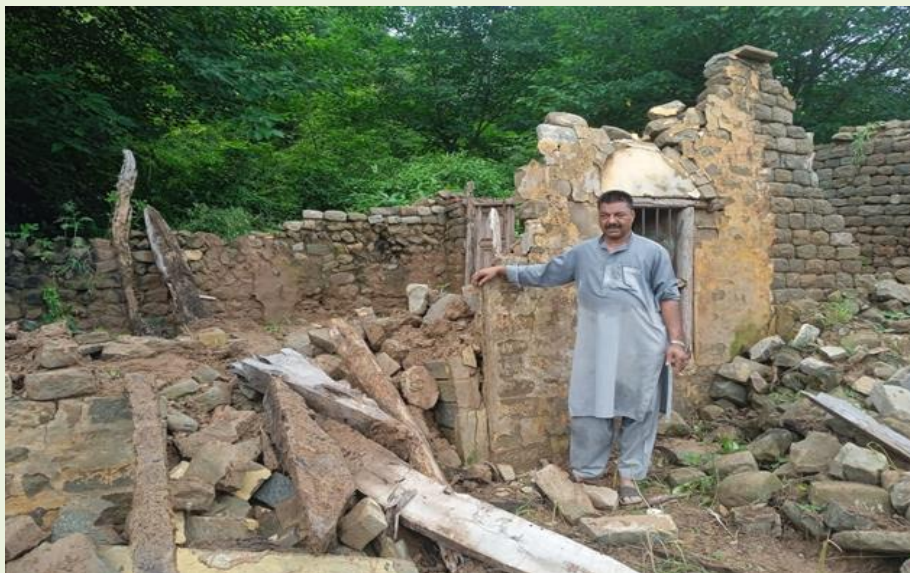
Figure 46: Structural Failure of an Aged Residential Unit in Mirpur Due to Lack of Maintenance

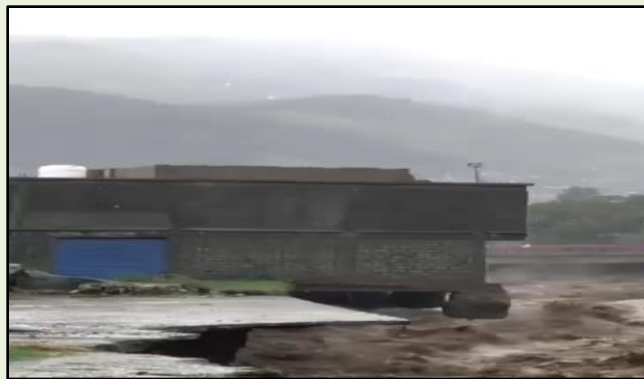
Figure 47: Structural Instability Caused by Foundation Soil Erosion

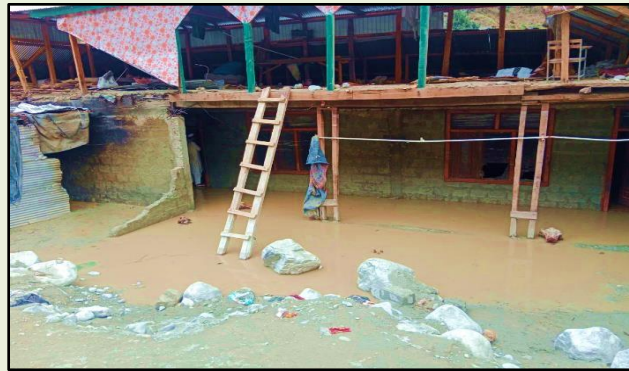
Figure 48: Waterlogging Around Residential Structures Due to Blocked Drainage Systems

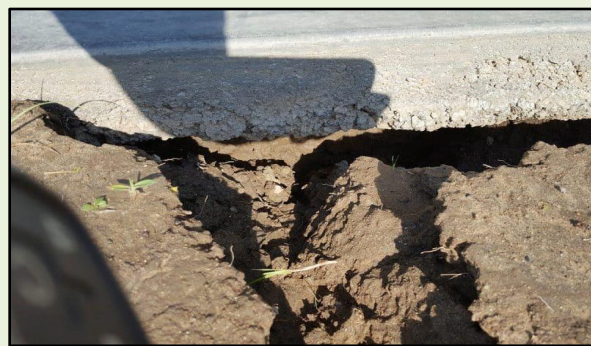
Figure 50: Ground Cracking and Structural Instability Due to Soil Settlement

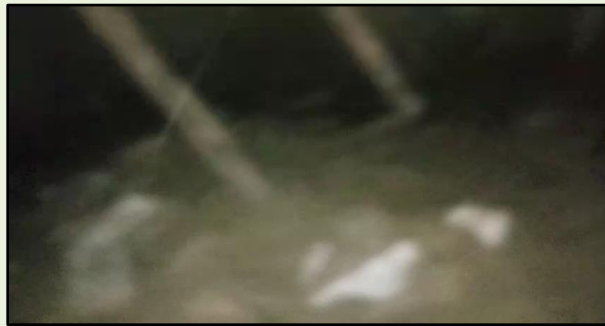
Figure 51: Water Accumulation and Structural Deterioration Due to Inadequate Drainage Planning

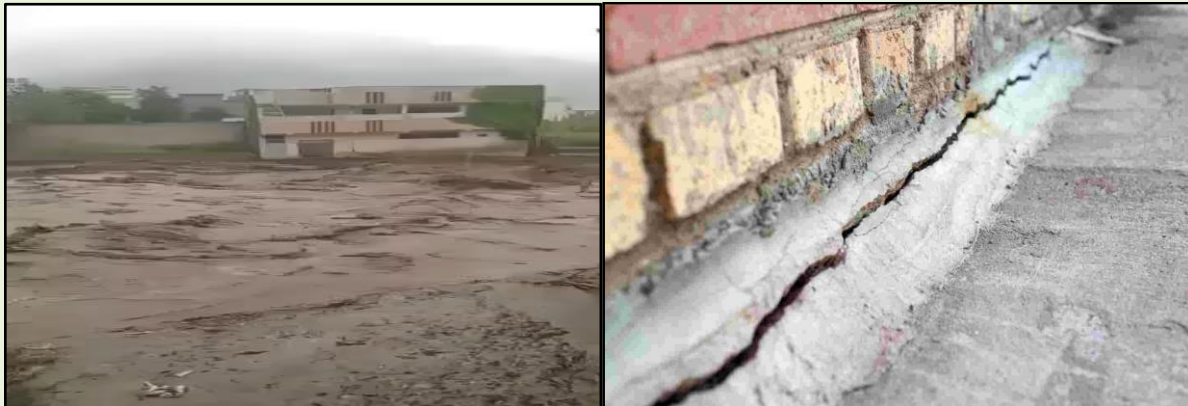
Figure 52: Foundation Failure and Structural Cracking Caused by Poor Drainage and Soil Instability

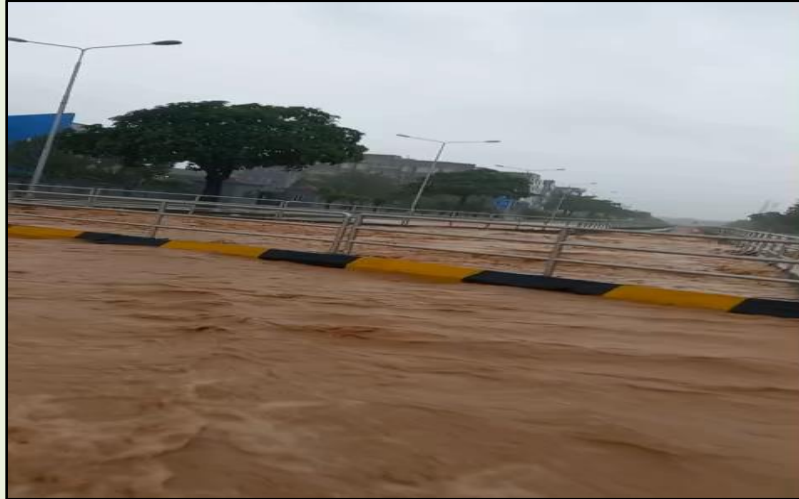
Figure 54: Urban Flooding Resulting from Poor Drainage and Undersized Hydraulic Structures

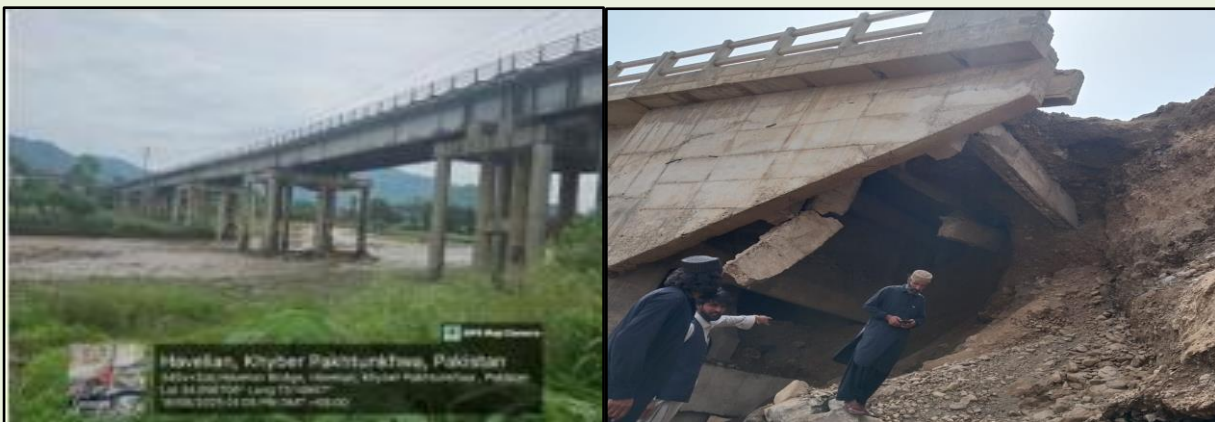
Figure 55: Structural Failures Due to Inadequate River Training and Scouring at Bridge Piers and Abutments

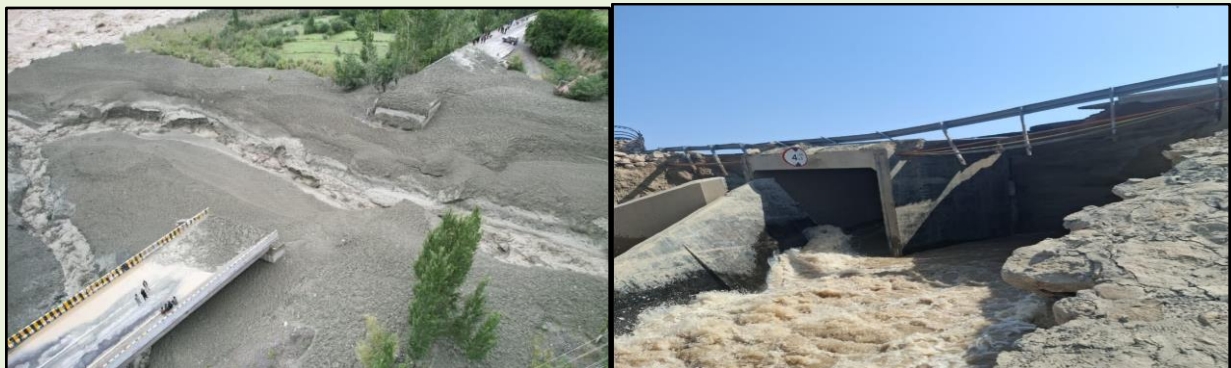
Figure 56: Structural Impacts of Sedimentation and Debris Load on Bridge and Culvert Systems

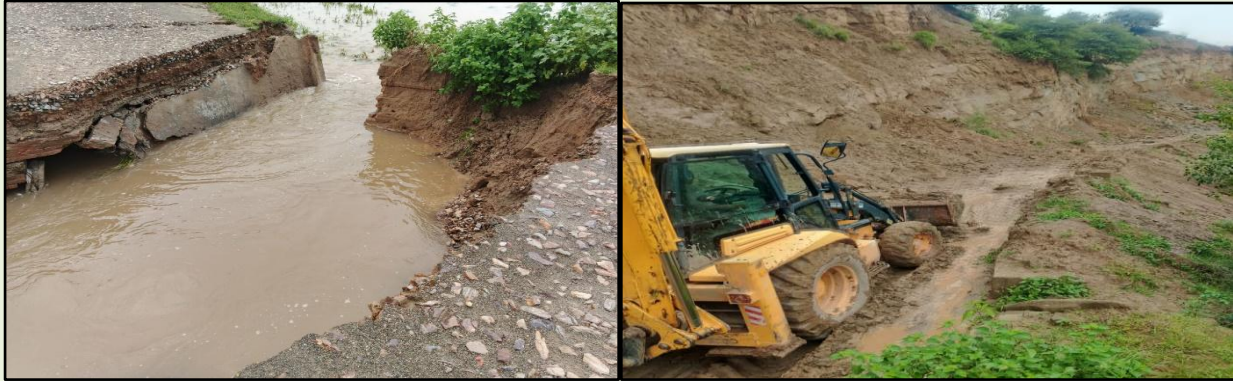
Figure 57: Road and Infrastructure Damage Caused by Soil Erosion and Landslide Deposition

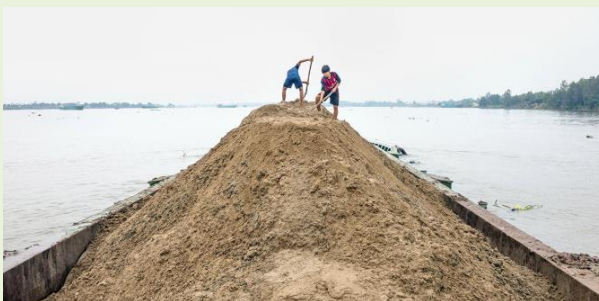
Figure 58: Unregulated river sand mining: a tale of survival, profit, and environmental loss

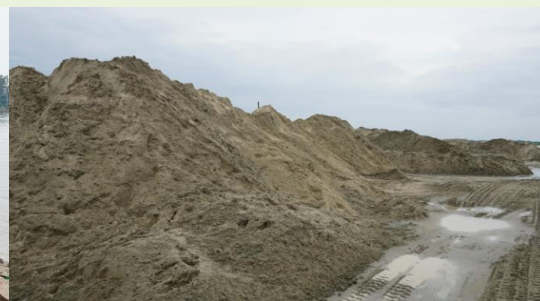
Figure 59: Accumulated sand from unregulated extraction activities, indicating unsustainable mining practices
