**National Disaster  
Management  
Authority**

# **Assessment of Infrastructure Failures & Resilience Needs**

**POST-MONSOON 2025**

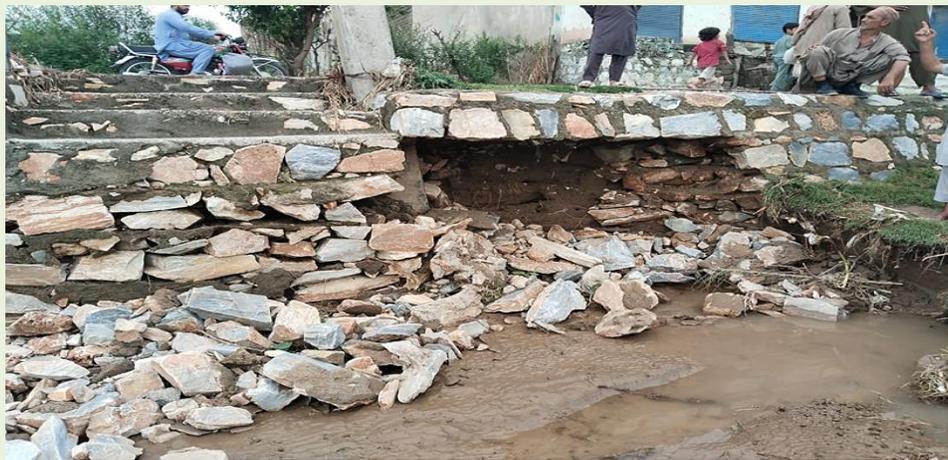
A flash flooding event struck parts of Swabi District, resulting in significant deterioration of binding materials and erosion at infrastructure bases. The forceful water flow eroded the supporting soil around small retaining walls and culverts, destabilizing foundations and threatening adjacent structures.

*Figure 3: Structural Erosion and Material Degradation in Swabi Following Flash Flood*

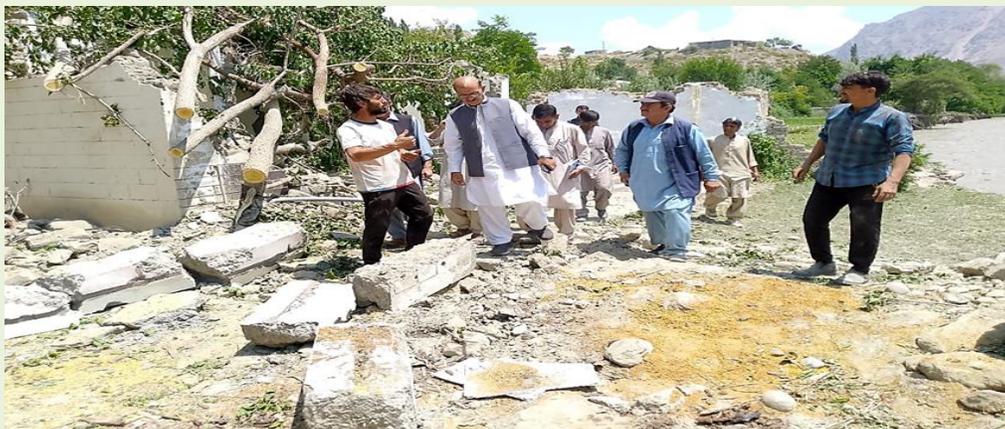
In Chitral District, intense flash floods led to house collapse and uprooting of trees, accompanied by extensive water seepage into residential structures. This incident highlighted the compounded effects of flash flooding in mountainous settlements.

*Figure 4: Ground Instability and Vegetation Uprooting in Chitral*

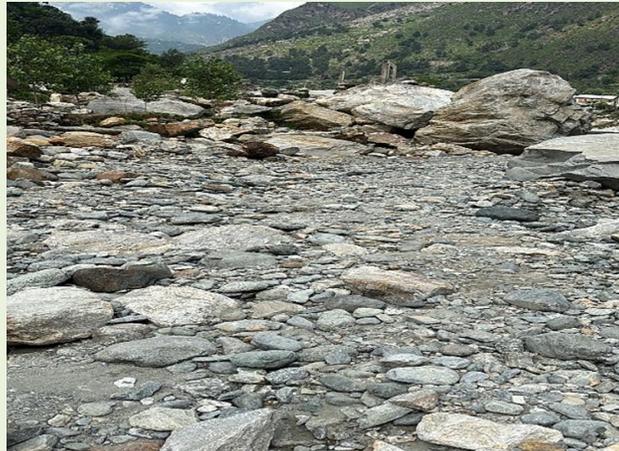
A major landslide in Lower Kohistan caused road blockages along key inter-district routes. The event was attributed to slope instability induced by persistent rainfall and loose geological formations. This incident underscores the vulnerability of the province's mountainous road infrastructure to recurring monsoon-induced landslides.

*Figure 5: Rainfall-Induced Slope Instability and Road Blockage in Lower Kohistan*

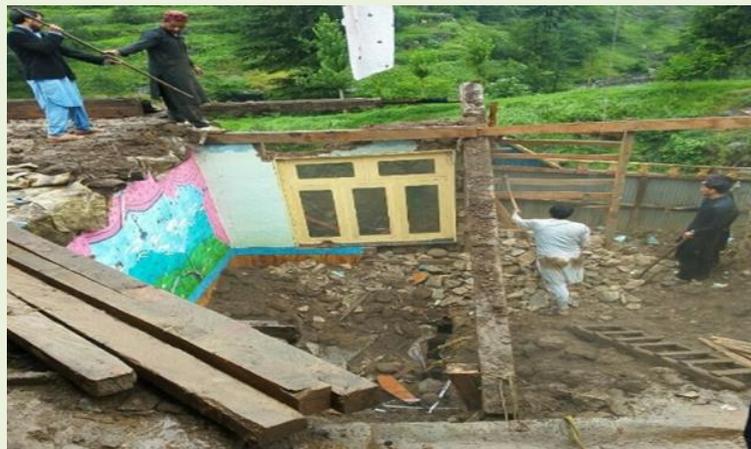
In Mansehra District, excessive rainfall led to water accumulation on rooftops, triggering structural failure and roof collapse in several houses. The incident reinforced the need for improved roofing materials and drainage systems, particularly in semi-urban and rural areas with non-engineered construction practices.

*Figure 6: Roof Collapse Due to Rainwater Accumulation*

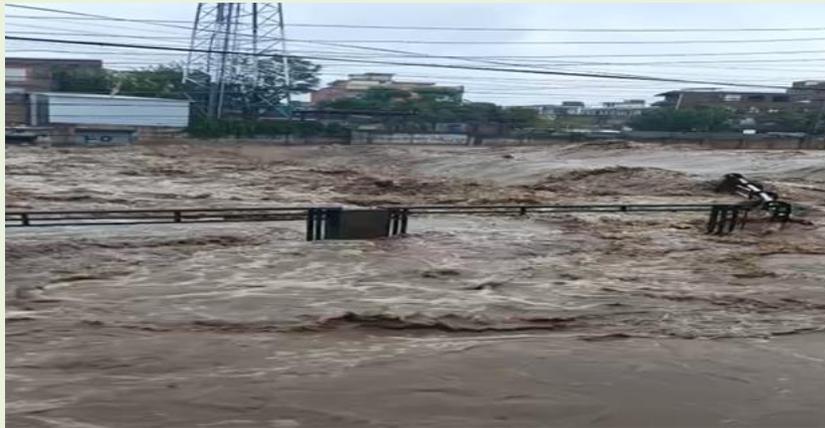
Heavy monsoon downpours in Swat District caused a flash flood, leading to extensive road blockages and the submergence of low-lying areas. The event exposed the lack of adequate drainage systems, as accumulated runoff overwhelmed local channels and roadways. This disrupted vehicular movement and isolated several adjoining communities.

*Figure 7: Severe Urban Flooding Due to Inadequate Drainage Infrastructure*

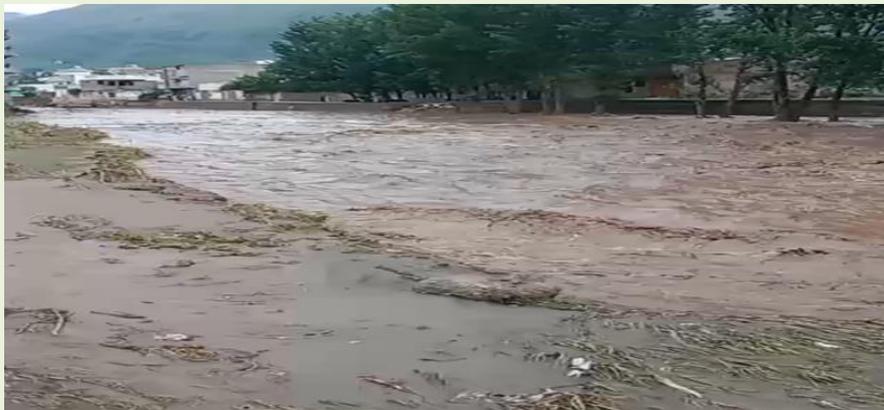
Just days later, another flood event on 18th August 2025 in Swat resulted in severe road erosion due to soil saturation and instability. Prolonged waterlogging weakened the road base, leading to partial collapses and posing hazards for transport and relief operations. This recurrence underscored the persistent threat of slope and soil failures in the northern highlands during sustained rainfall.

*Figure 8: Flash Flood-Induced Inundation Due to Inadequate Urban Drainage*

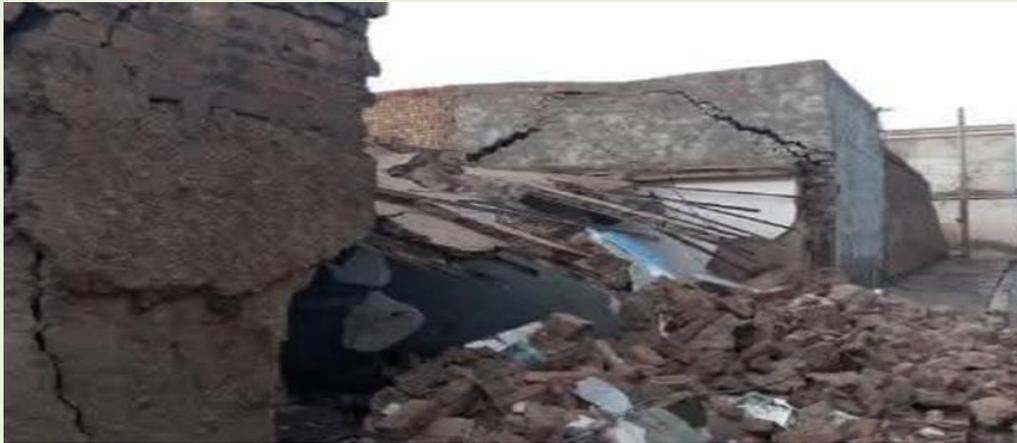
In Dera Ismail Khan, intense rainfall led to the collapse of multiple houses, revealing major concerns regarding structural integrity in vulnerable settlements. The incident caused displacement of affected households and significant property losses.

Figure 9: Structural Collapse of Houses

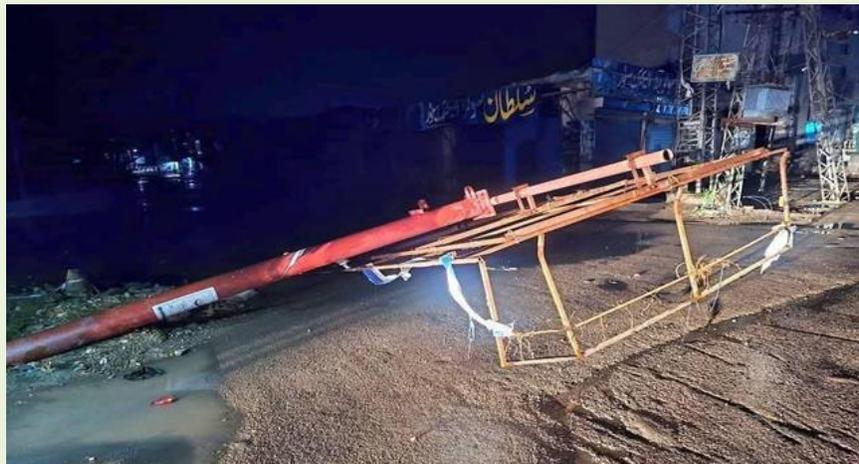
Concurrent to the heavy rains, strong winds toppled electrical poles, leading to temporary power outages in several urban and semi-urban areas. The damage was linked to the lack of bracing and structural reinforcement in electrical infrastructure, further emphasizing the cascading impact of monsoon-induced weather conditions on critical lifelines.

Figure 10: Failure of Unbraced Electrical Pole Infrastructure

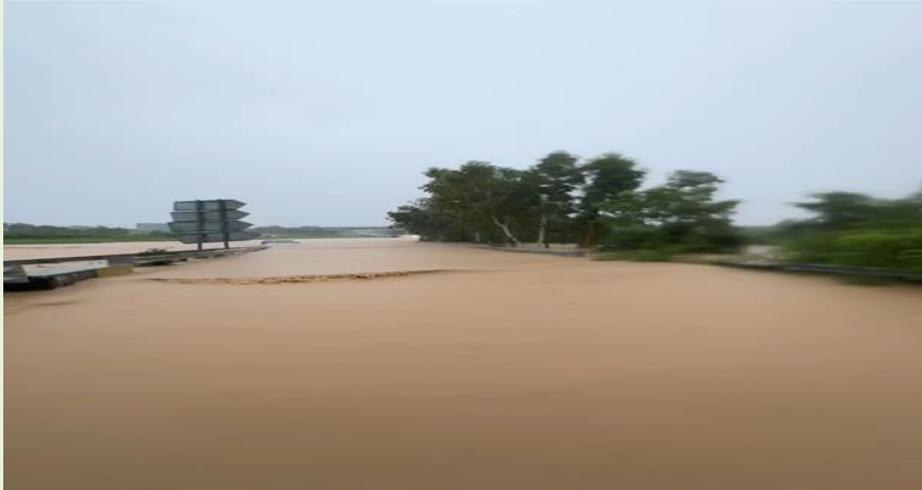
identified as the blockage of the drainage network, which prevented effective runoff management. This event underscores the urgent need for routine maintenance and regular desilting of stormwater channels along major transport corridors.

*Figure 12: Flooding and Water Accumulation on Motorway Due to Blocked Drainage Network*

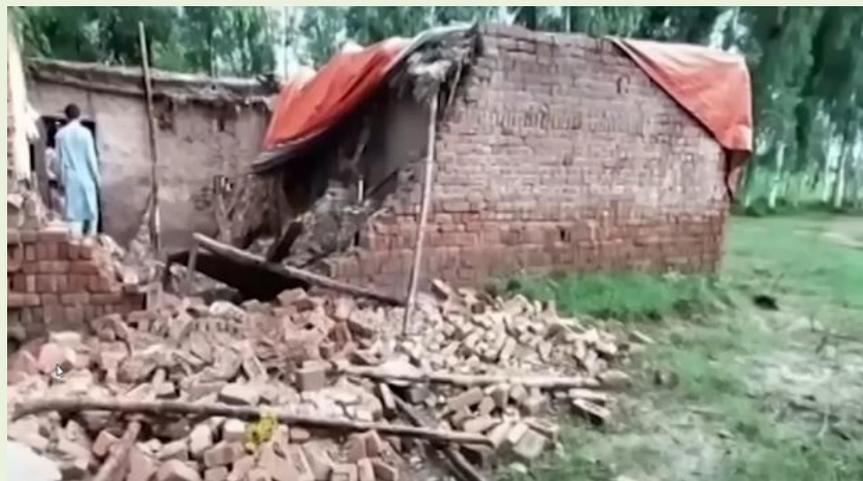
In Sargodha, continuous rainfall caused the collapse of residential structures, revealing critical weaknesses in local construction practices. The use of substandard building materials and the lack of proper reinforcement were major contributing factors. These findings call for stricter enforcement of building codes and quality control measures, particularly in flood-prone rural settlements.

*Figure 13: Structural Collapse of Residential Houses in Sargodha Due to Poor Construction Practices*

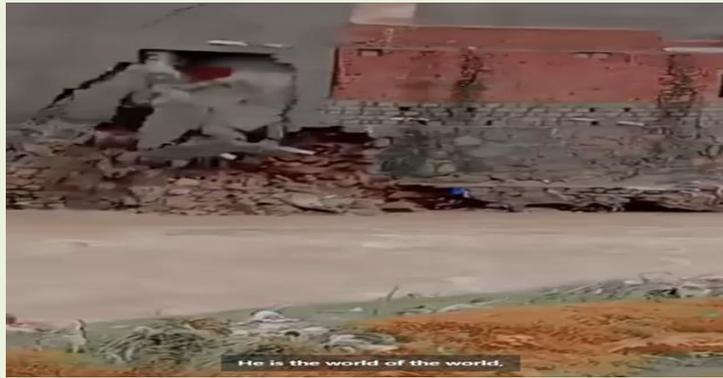
In Rawalpindi, flooding led to the collapse of a residential house, primarily due to foundation settlement and soil erosion. The incident highlights the vulnerability of low-lying urban areas where unplanned drainage and weak soil conditions exacerbate the effects of heavy rainfall. Improved geotechnical assessment and flood-resilient construction practices are required to mitigate similar future losses.

Figure 14: Structural Failure of Residential Building Due to Foundation Settlement and Erosion

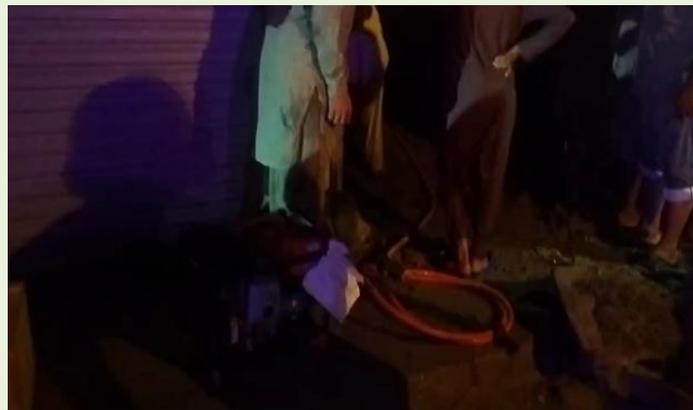
In Muzaffargarh, intense rainfall caused the collapse of a roof, attributed to water ponding and insufficient roof drainage systems. The event reveals the recurring issue of poor design and maintenance in residential roofing structures. Incorporating roof slope standards, effective drainage outlets, and regular inspections could significantly reduce such risks.

Figure 15: Roof Collapse in Muzaffargarh Due to Water Ponding and Inadequate Drainage

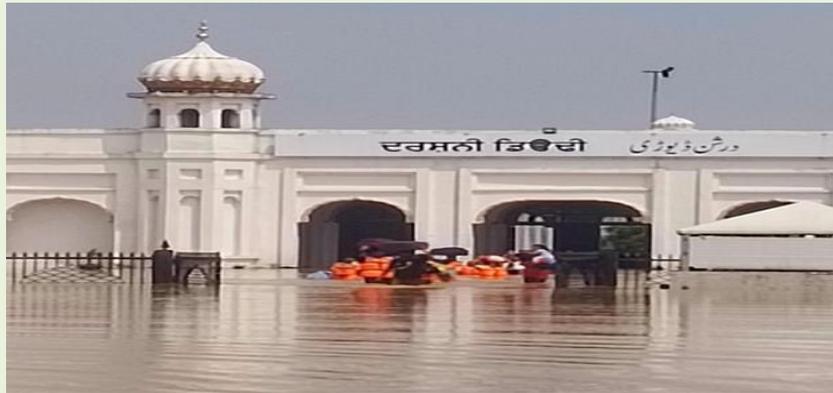
The Kartarpur Corridor in Narowal experienced severe flooding as a result of poor drainage design and insufficient runoff management. The inundation affected access routes and religious infrastructure, hampering mobility and emergency response. The event emphasizes the necessity for incorporating hydrological assessments and flood-proof design features in sensitive and high-footfall public facilities.

Figure 16: Flooding at Kartarpur Corridor, Narowal Due to Inadequate Drainage Infrastructure

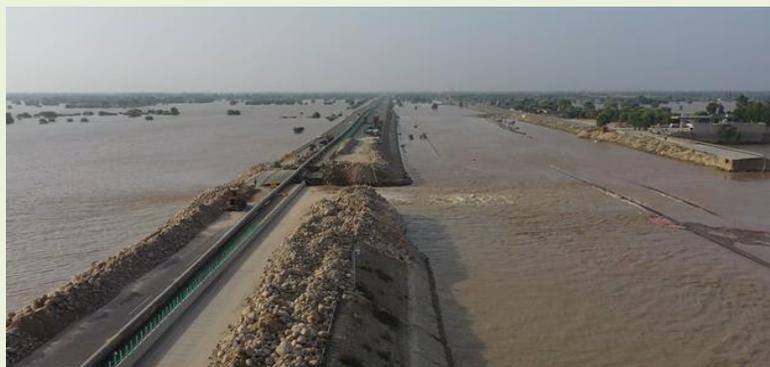
One of the most significant infrastructural failures occurred along the M-5 Multan Motorway, where intense flooding resulted in road erosion and partial collapse of the motorway embankment. The incident revealed underlying vulnerabilities linked to inadequate slope protection, soil compaction issues, and weak embankment stabilization. The scale of damage disrupted inter-district connectivity and underscored the urgent requirement for engineering interventions such as reinforced retaining structures, improved drainage outlets, and flood-resilient pavement materials.

Figure 17: Flood-Induced Erosion and Embankment Collapse on M-5 Motorway, Multan

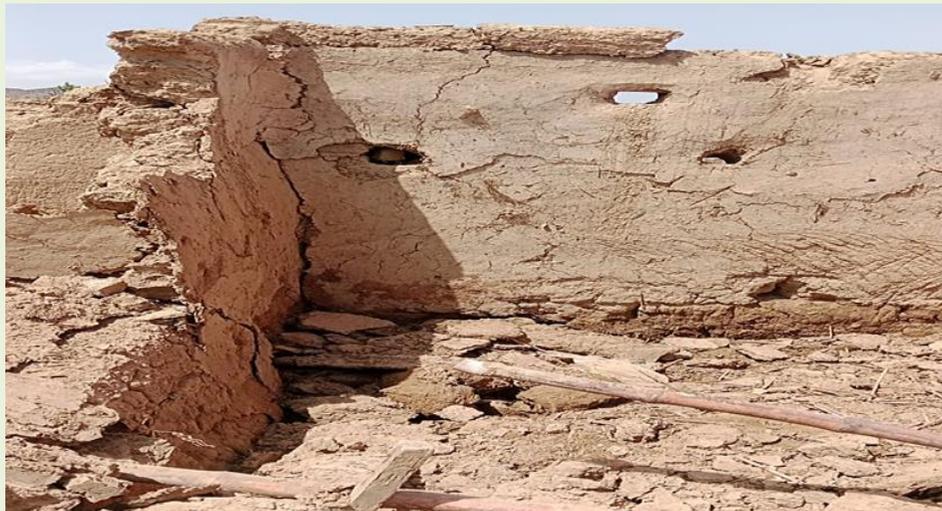
In Musakhail, intense and sustained rainfall on 24th August 2025 resulted in the complete collapse of one residential unit and partial structural damages to more than 30 adjoining houses. The affected structures predominantly comprised earthen and unreinforced masonry materials with inadequate foundations and poor load-bearing capacity. Prolonged moisture infiltration led to the weakening of wall integrity and subsequent localized failures. The incident highlights the high vulnerability of non-engineered construction to hydro-meteorological stresses and reinforces the necessity for promoting resilient building practices, proper drainage planning, and structural reinforcement in flood-prone rural settlements.

*Figure 19: House Damage in Musakhail due to Intense Rainfall*

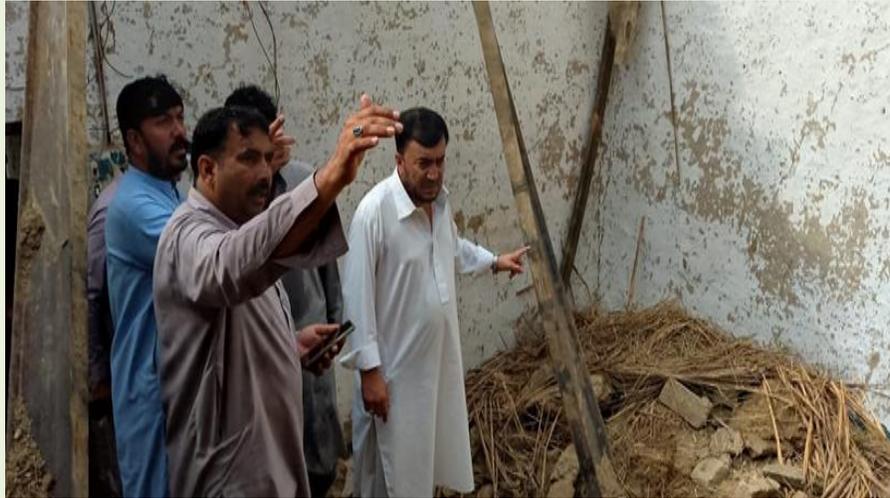
In Harnai, intense rainfall on 18th August 2025 caused the collapse of a residential roof structure. The failure occurred primarily due to the saturation of mud-based roofing materials and the absence of adequate load distribution supports. Field inspection indicated that excessive moisture penetration led to the disintegration of binding materials and subsequent collapse under self-weight. The incident underscores the structural vulnerability of non-engineered housing units to heavy precipitation events and emphasizes the urgent requirement for introducing reinforced roofing systems, improved drainage around foundations, and adherence to resilient construction standards in rural settlements.

Figure 20: Roof Collapse in Harnai due to Intense Rainfall

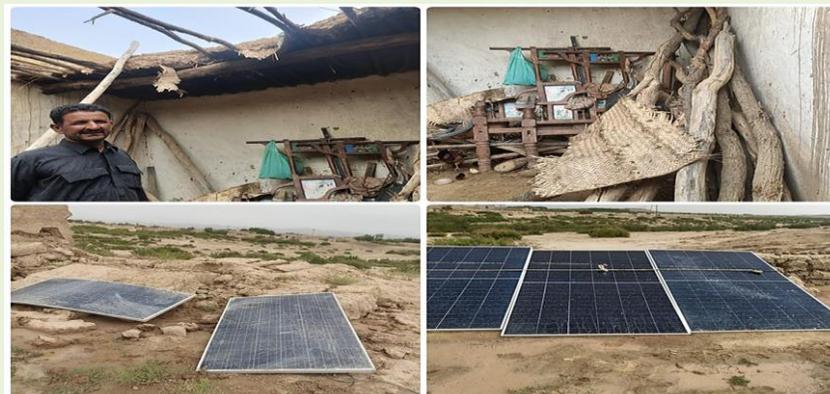
In Surab, a windstorm accompanied by heavy rainfall on 6th July 2025 caused the collapse of residential roof structures and significant damage to solar energy installations. The affected buildings were primarily non-engineered, utilizing wooden trusses and mud plaster, which failed under combined wind pressure and moisture ingress. Several rooftop solar panels and ground-mounted photovoltaic units were dislodged or tilted due to inadequate anchoring and soil erosion around foundations. The incident illustrates the compounded vulnerability of both traditional housing and renewable energy infrastructure to extreme weather conditions, emphasizing the requirement for improved structural anchorage, wind-resistant roofing systems, and climate-resilient solar installations in hazard-prone regions.

Figure 21: Roof and Solar Infrastructure Damage in Surab due to Heavy Rainfall

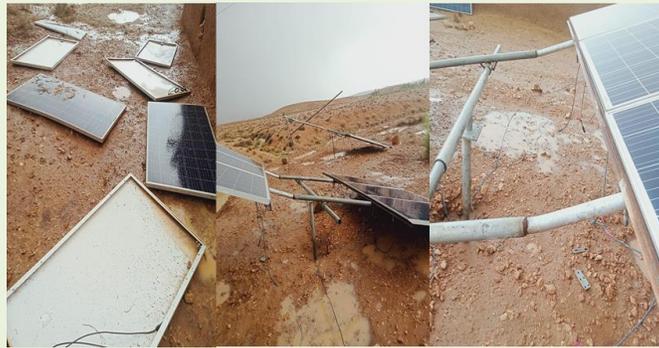
Figure 22: Solar Infrastructure Damage due to Heavy Rainfall

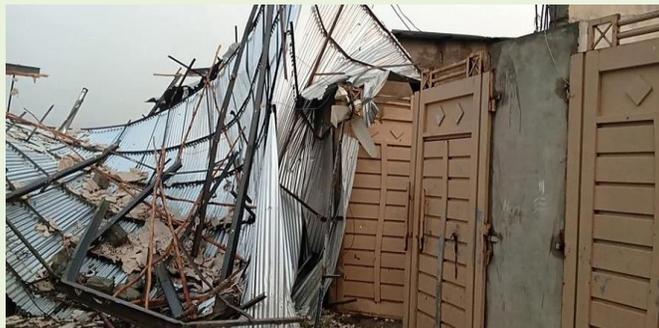
Figure 23: Roof Collapse in Muslim Bagh due to Heavy Rainfall

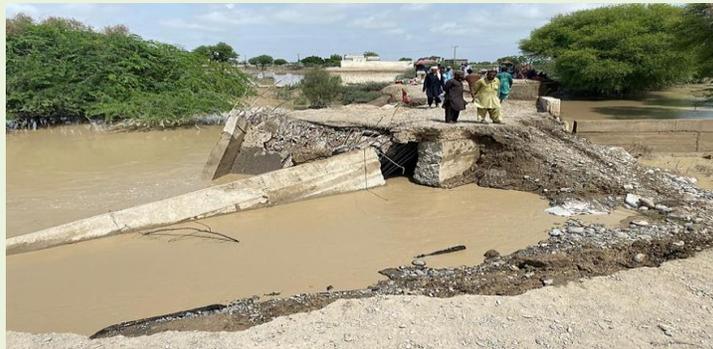
*Figure 24: Bridge Washed Away in Lasbela due to Severe Flashflood*

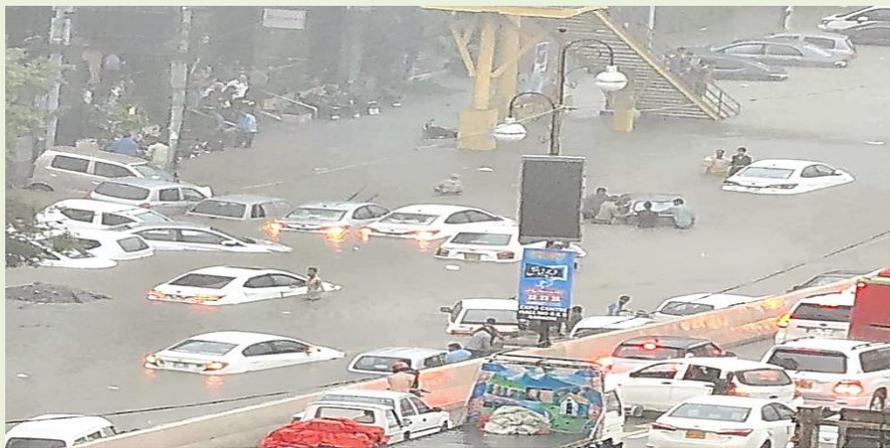
Figure 26: Urban Flooding in Karachi due to Intense and Prolonged Rainfall

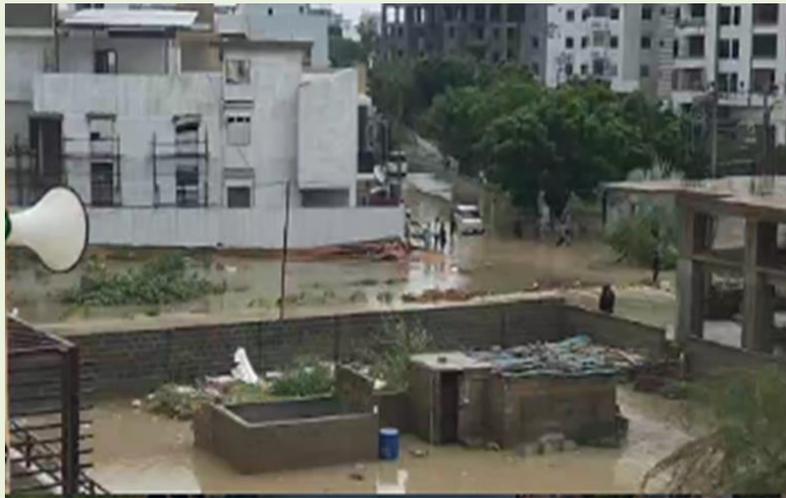
*Figure 27: Building Collapse in Karachi due to Heavy and Persistent Rainfall*

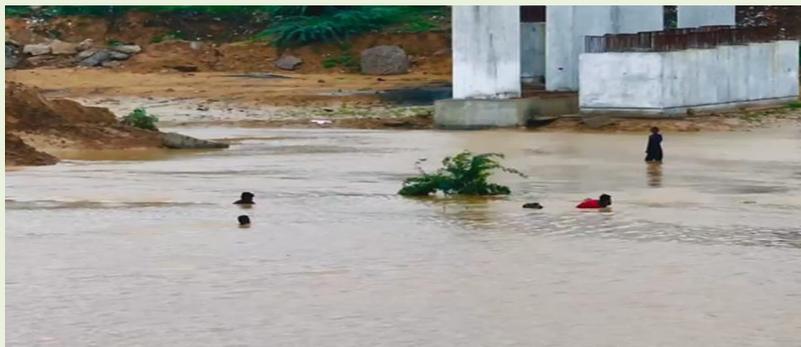
*Figure 29: Urban Flooding in Malir, Karachi due to Intense Monsoon Rainfall*

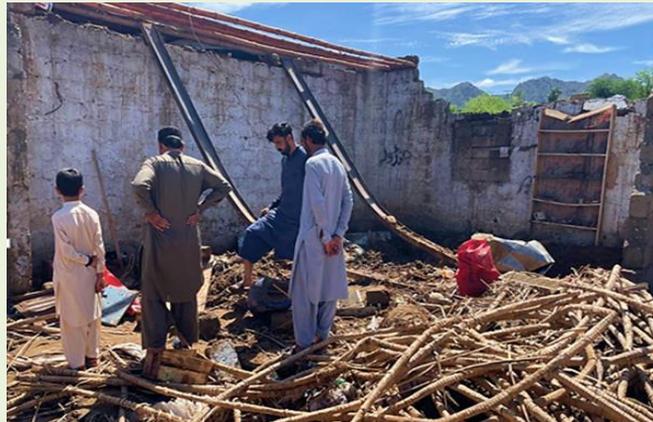
*Figure 30: Roof Collapse in Lyari, Karachi due to Heavy Rainfall*

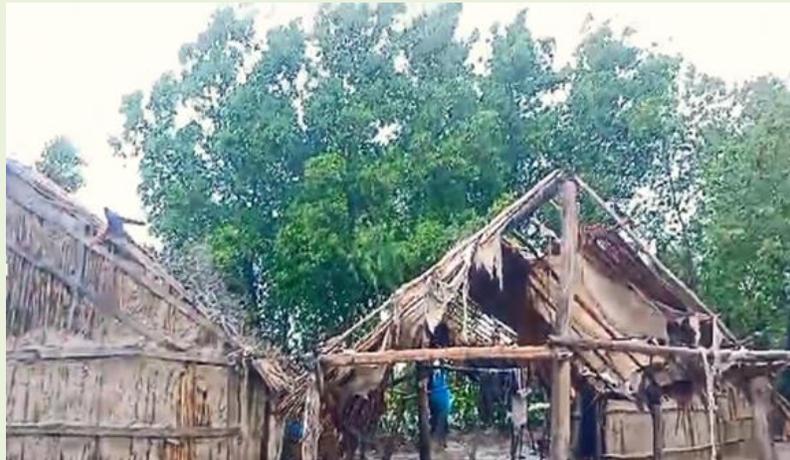
*Figure 31: Mud and Thatch House Damage due to Flash Flooding Triggered by Intense Monsoon Rainfall*

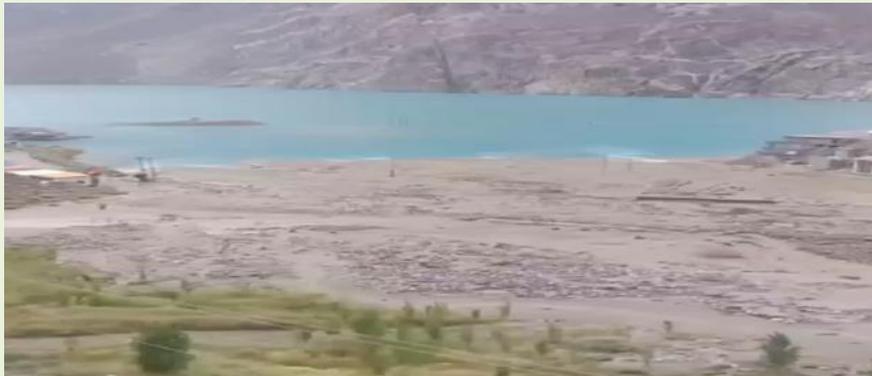
Figure 33: Road Damage at Brundubar Nullah, Hunza – Result of Inadequate Design

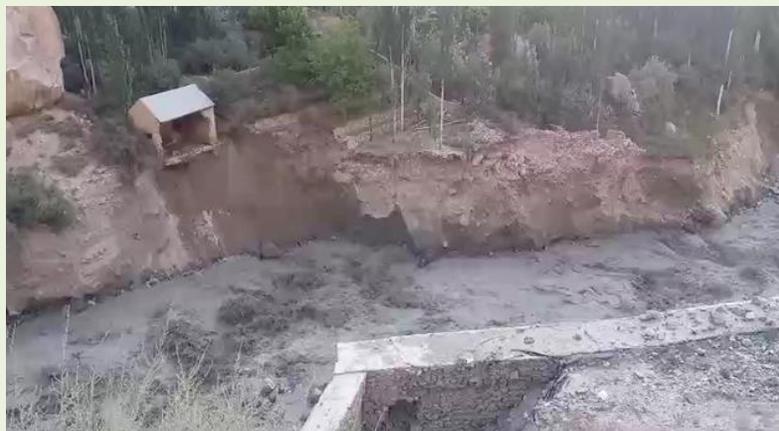
Figure 34: Riverbank Erosion and Slope Failure at Shishper Following GLOF Event

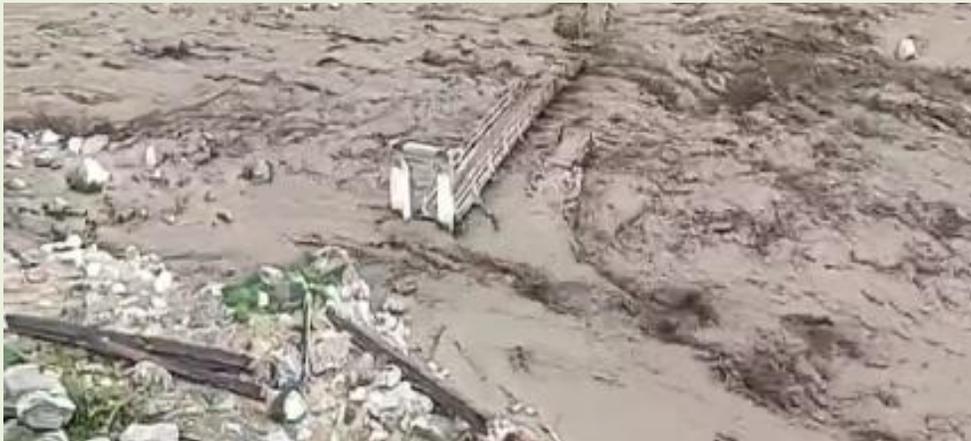
*Figure 35: Bridge Collapse at Babusar–Chilas Following Cloud Burst*

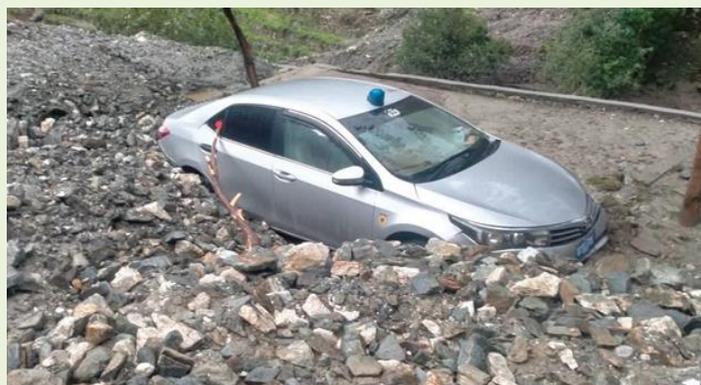
*Figure 36: Rainfall-Induced Landslide and Infrastructure Damage at Babusar–Chilas*

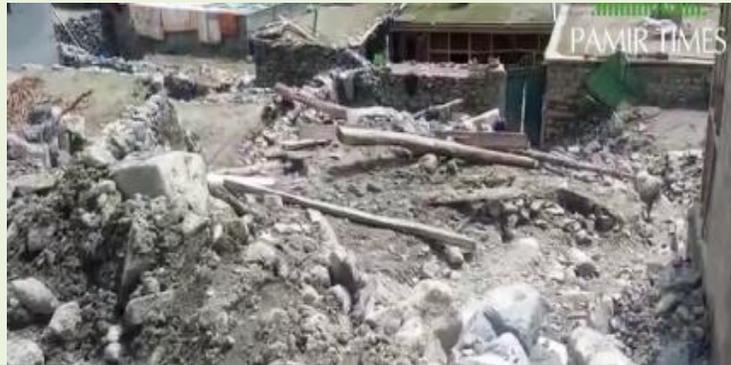
*Figure 37: Structural Collapse of Residential Houses in Gilgit Following Flash Flood*

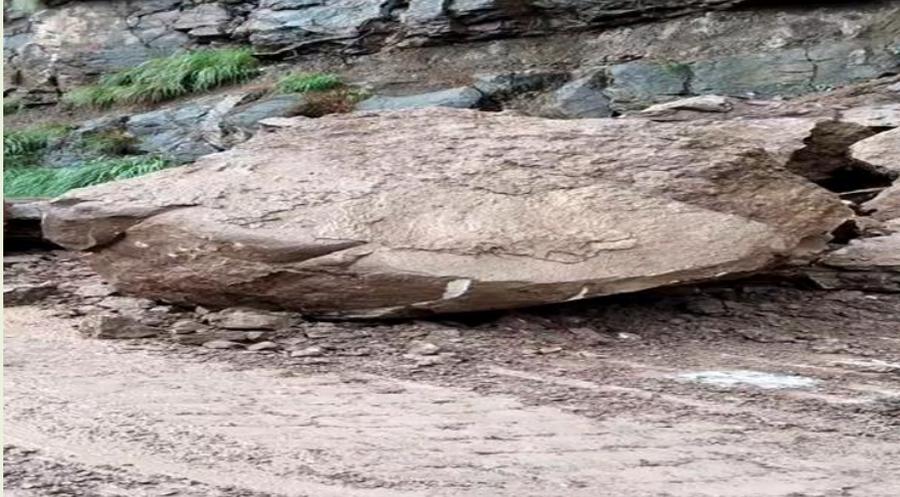
*Figure 39: Landslide-Induced Road Blockage in Pallandri Due to Unstable Rocky Slopes*

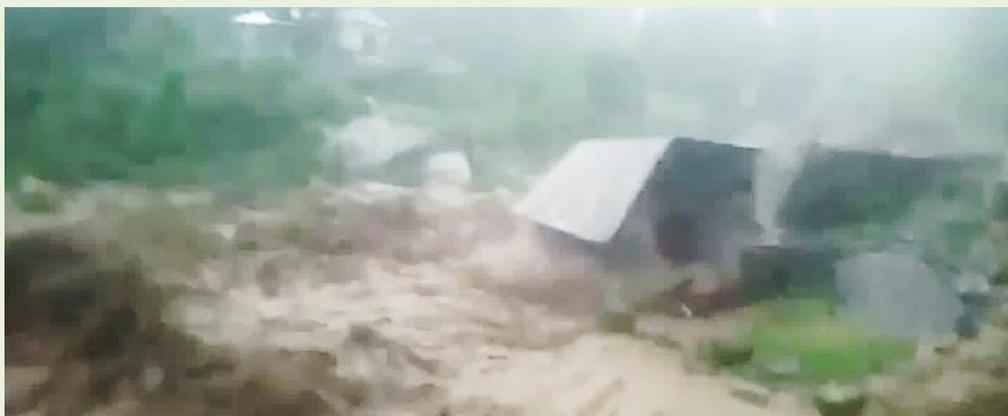
*Figure 40: Flash Flood Impact in Neelum Due to Construction within Floodplain Areas*

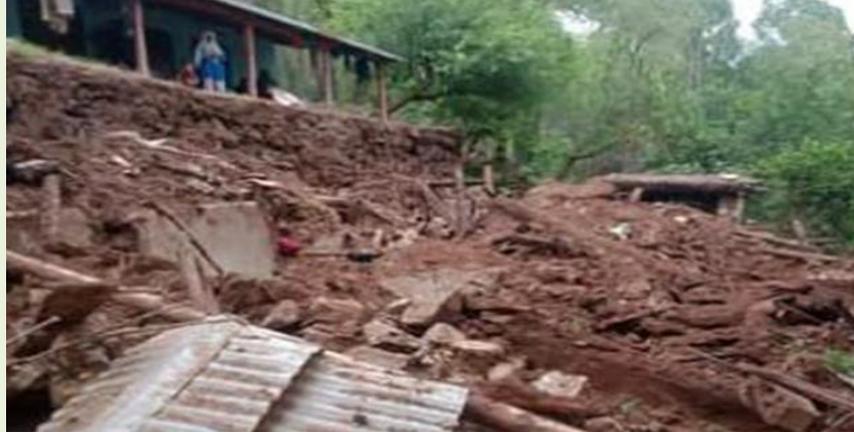
*Figure 41: Structural Collapse of Residential Buildings in Sudhnoti Due to Weak Design and Materials*

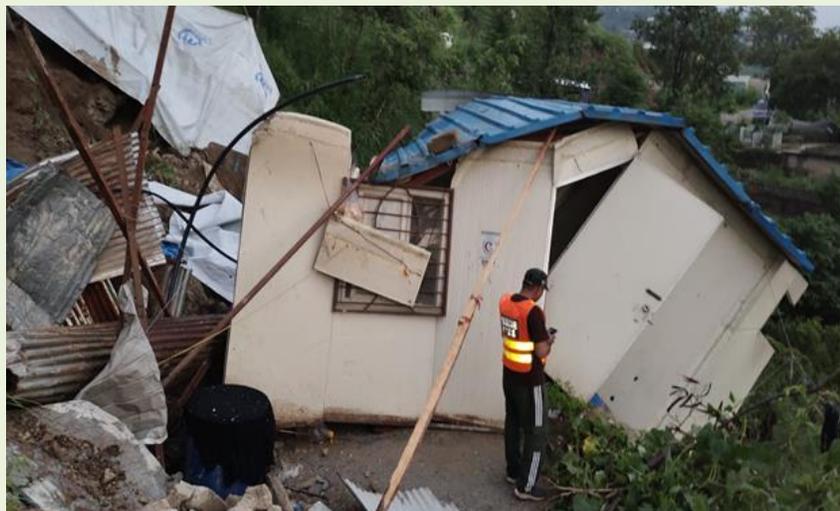
*Figure 42: Structural Collapse of a Residential Unit in Muzaffarabad Due to Poor Site Selection*

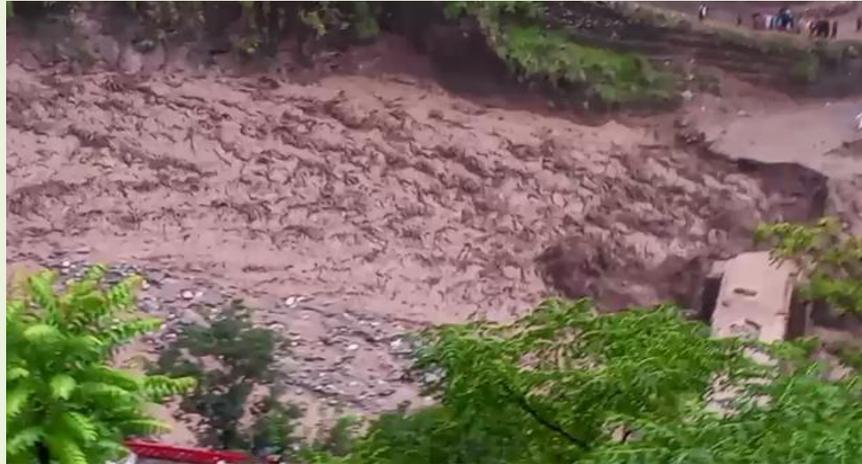
Figure 43: Bridge Collapse in Neelum Due to Flood-Induced Structural Failure

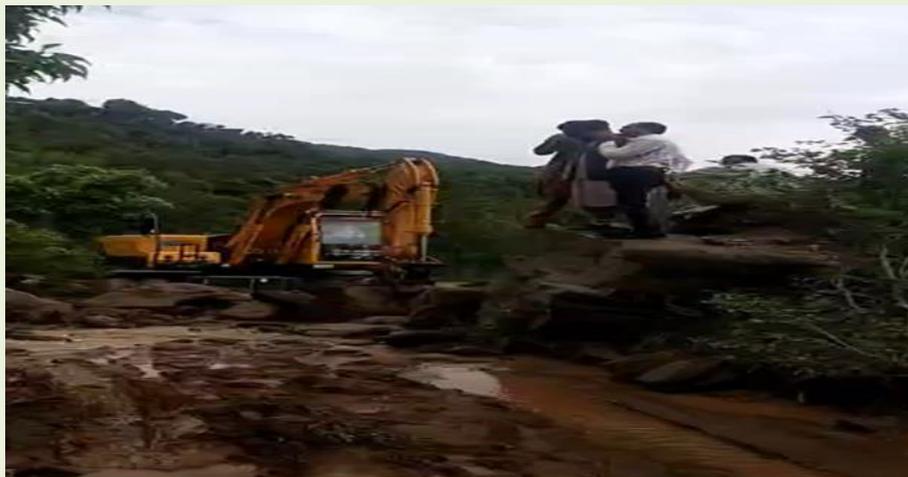
Figure 44: Landslide in Sudhnoti Triggered by Heavy Rainfall and Absence of Retaining Structures

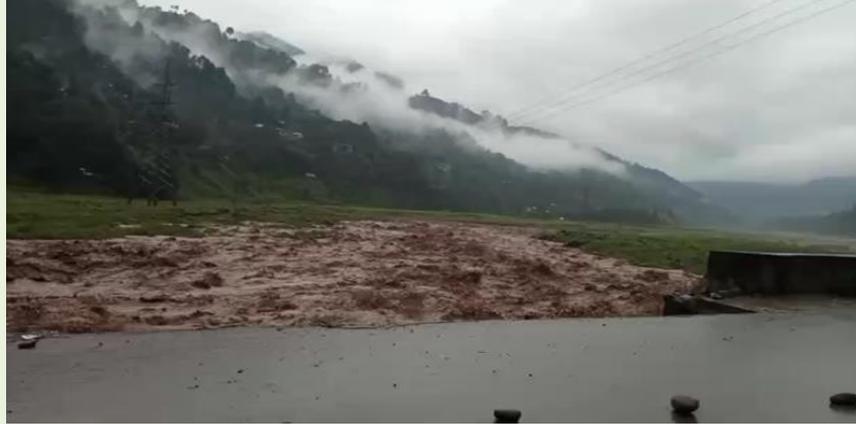
*Figure 45: Road and Riverbank Erosion in Bagh Due to Absence of Stabilization Measures*

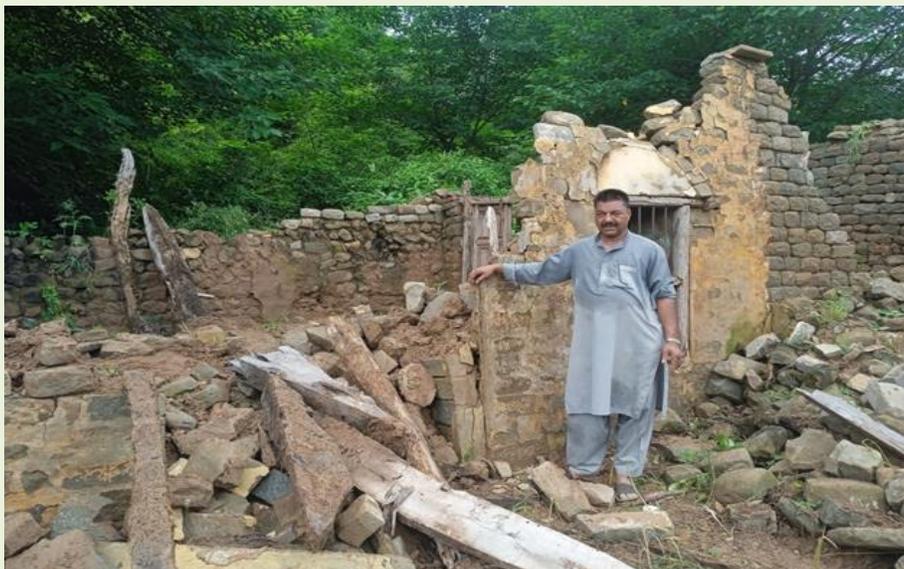
*Figure 46: Structural Failure of an Aged Residential Unit in Mirpur Due to Lack of Maintenance*

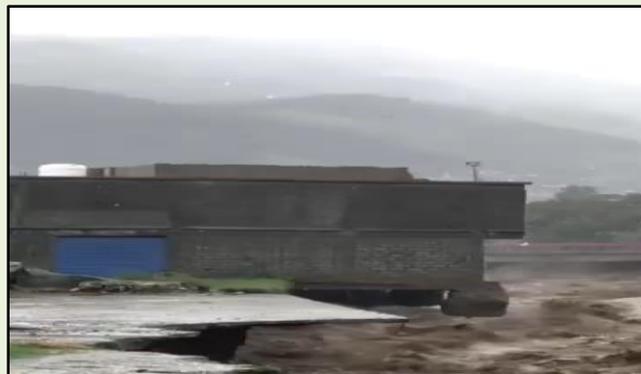
*Figure 47: Structural Instability Caused by Foundation Soil Erosion*

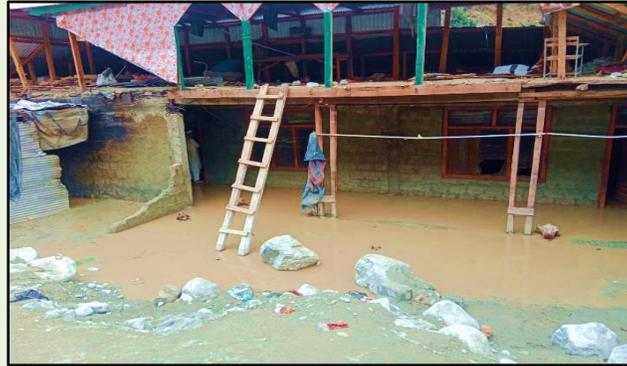
Figure 48: Waterlogging Around Residential Structures Due to Blocked Drainage Systems

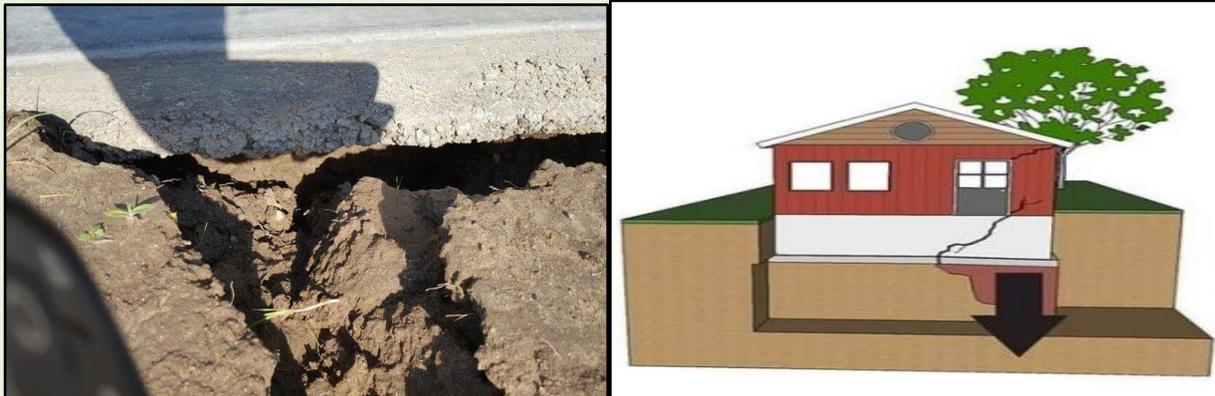
Figure 49: Left-Ground Movement and Right-Differential Settlement

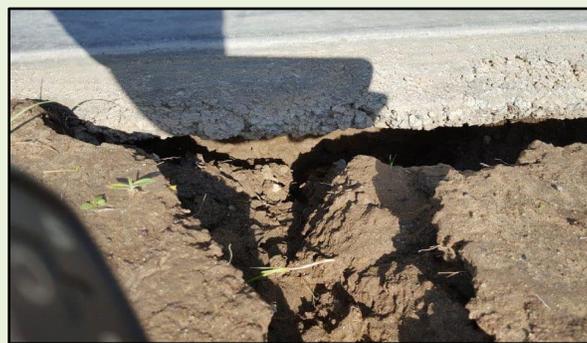
*Figure 50: Ground Cracking and Structural Instability Due to Soil Settlement*

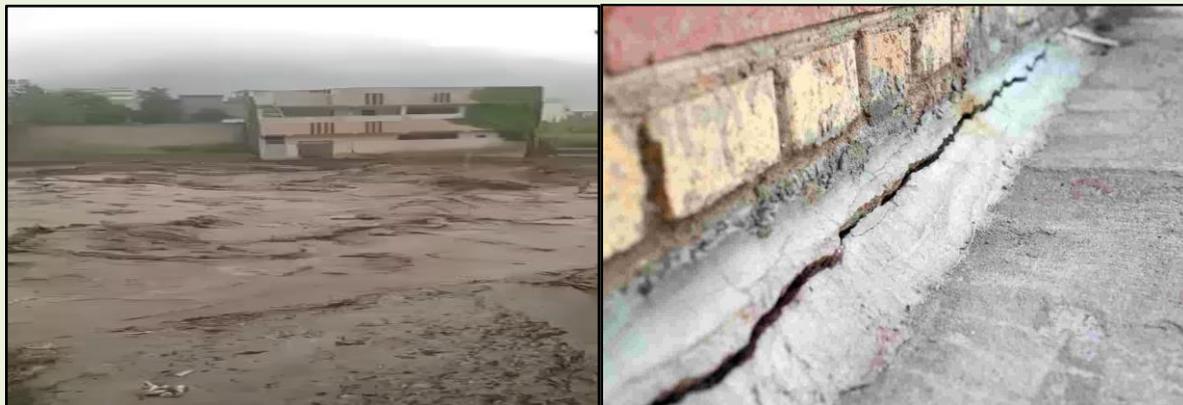
*Figure 52: Foundation Failure and Structural Cracking Caused by Poor Drainage and Soil Instability*

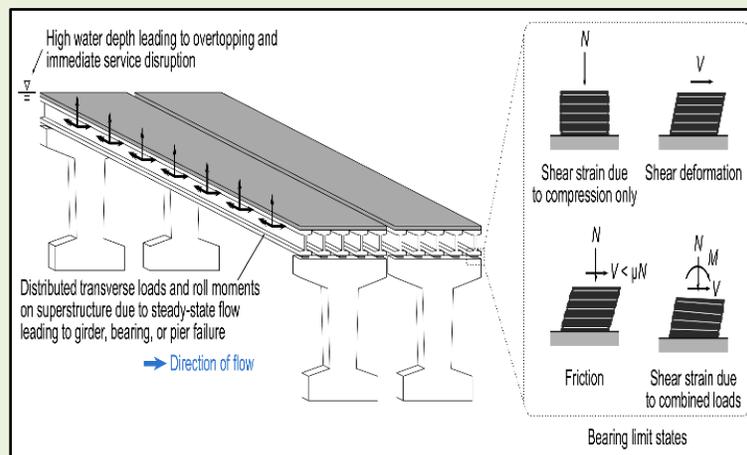
Figure 53: Structural Behavior and Failure Mechanisms Due to Design Deficiencies in Bridge Systems

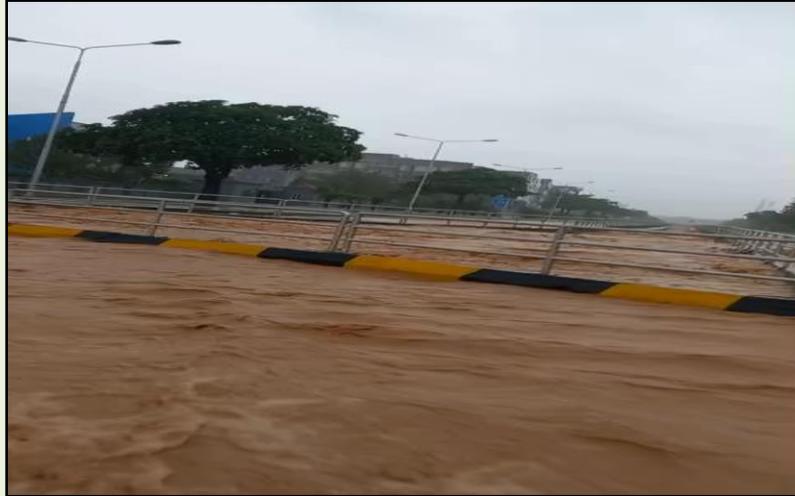
Figure 54: Urban Flooding Resulting from Poor Drainage and Undersized Hydraulic Structures

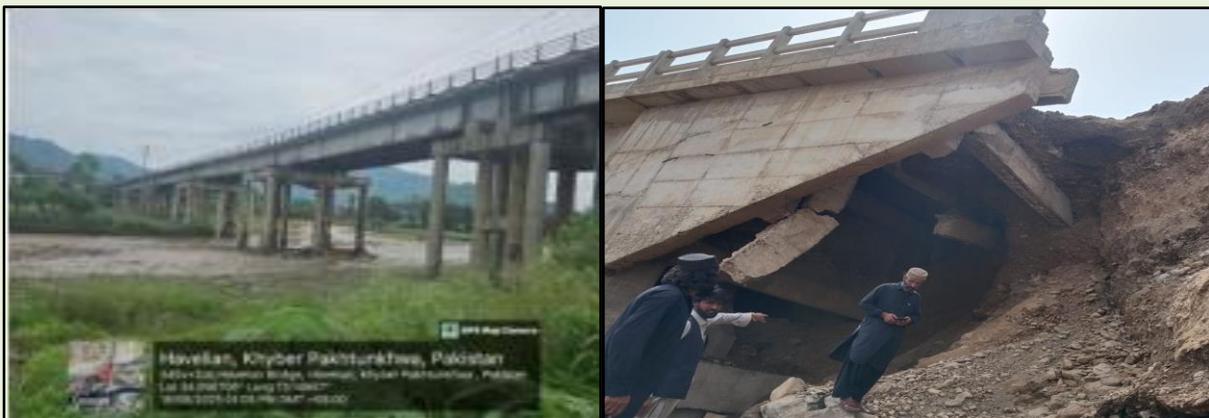
Figure 55: Structural Failures Due to Inadequate River Training and Scouring at Bridge Piers and Abutments

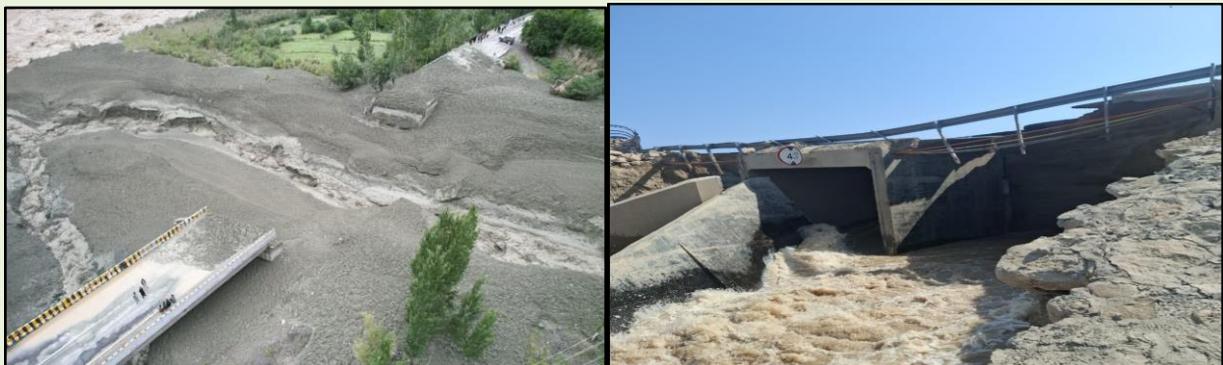
*Figure 56: Structural Impacts of Sedimentation and Debris Load on Bridge and Culvert Systems*

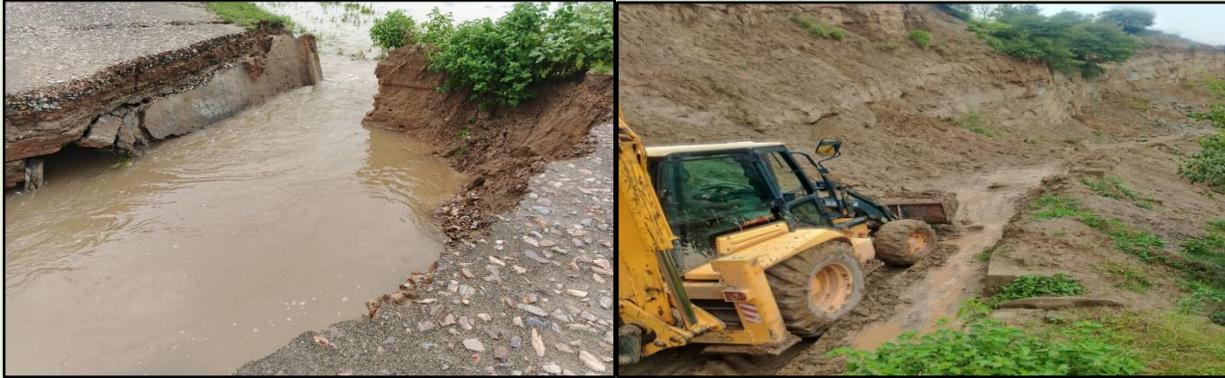
Figure 57: Road and Infrastructure Damage Caused by Soil Erosion and Landslide Deposition

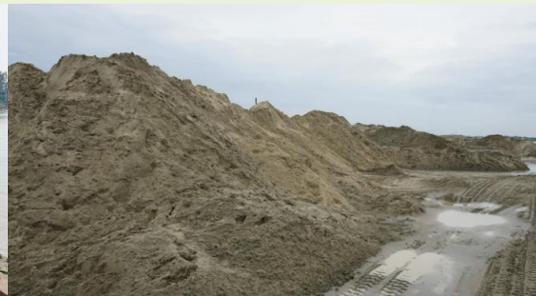
Figure 59: Accumulated sand from unregulated extraction activities, indicating unsustainable mining practices
