**NATIONAL DISASTER MANAGEMENT AUTHORITY**

# POST-MONSOON 2026

## ASSESSMENT OF INFRASTRUCTURE DAMAGES & RESILIENCE NEEDS REPORT

**INFRASTRUCTURE ADVISORY  
& PROJECT DEVELOPMENT (IA&PD) WING**

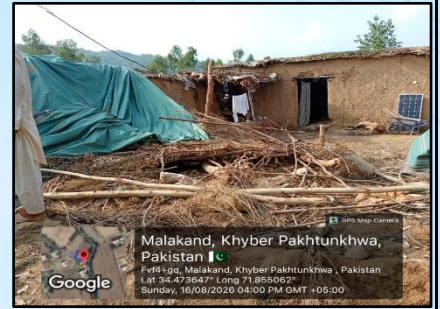
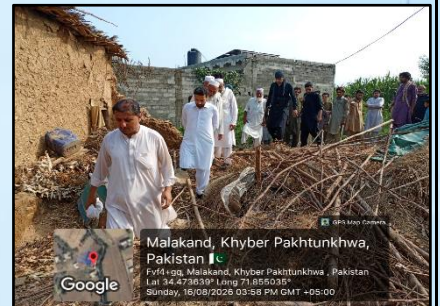
Wazir Abad, Tehsil Dargai, District Malakand | Room Collapsed | 16th Aug 2026 | Completely Damaged

**Structure Type:** Adobe Structure. The affected dwelling is an adobe residential structure whose earthen walls and roof are particularly vulnerable to prolonged rainfall and moisture saturation.

**Cause:** Heavy rainfall saturated and weakened the adobe walls and roof, causing structural collapse. Persistent heavy rainfall increased moisture content in the adobe elements, reducing their strength and leading to failure of the walls and roof.

**Prominent Hazards:** Flash Floods, Soil/Bank Erosion, Debris Flow, Earthquake, Landslide. The mixed hilly and plain setting can experience concentrated runoff, erosion and debris movement, while slope instability and seismic hazards increase vulnerability of exposed settlements.

Reconstruct using stabilized masonry on a raised foundation with a weatherproof roof and proper site drainage. Reconstruction should use moisture-resistant stabilized masonry, elevate the building above local runoff levels, and provide effective roof and site drainage to reduce recurrence of rain-induced damage.

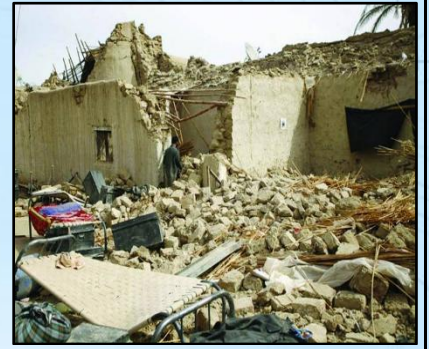
**Prominent Hazards:** Earthquake. The intermontane setting lies within an active tectonic environment where seismic loading can impose significant lateral demand on vulnerable earthen structures.

Reconstruct using confined adobe construction with wire mesh or polymer geomesh, tie columns, stabilized adobe blocks. Reconstruction should use confined adobe techniques and improved connections to enhance wall integrity, seismic performance and overall structural resilience.

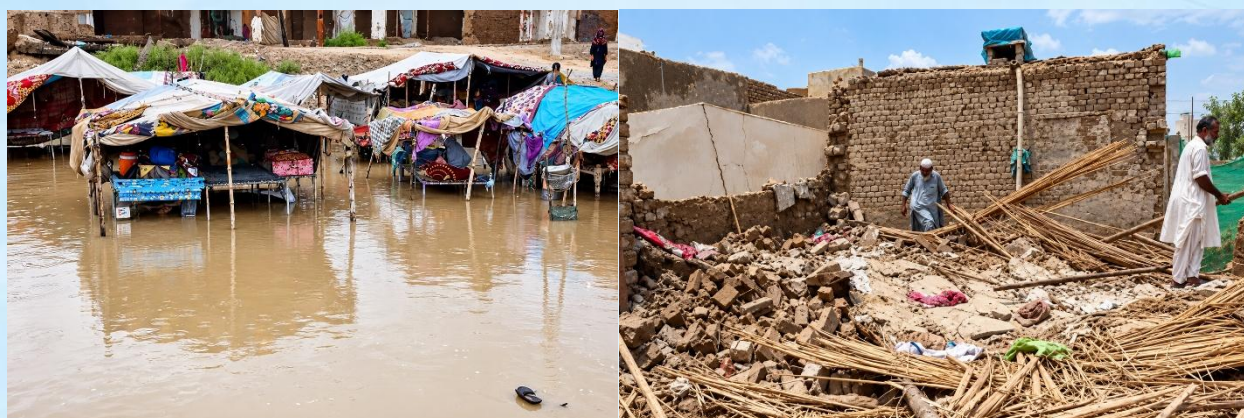
Figure 5: Location: Tharparkar, Event: Rainfall / Lightening

The structural failures across these events were primarily caused by prolonged basal moisture ingress, hydraulic scour, and the extreme saturation of informal roofing materials. Stagnant surface water caused deep subgrade soil saturation, which stripped shallow foundations of their bearing capacity and led to differential settlement and wall cracking in semi-pakka buildings. Additionally, capillary action and sudden hydraulic scour, exacerbated

in one instance by 15-foot and 8-foot breaches in Badin's Mirwah Canals, severely eroded the unreinforced mud-mortar joints and earthen bases of traditional walls. Overhead, the high-intensity downpours exceeded the moisture absorption limits of traditional thatched and timber canopies, triggering direct roof cave-ins due to the heavy dead-weight of the saturated materials.

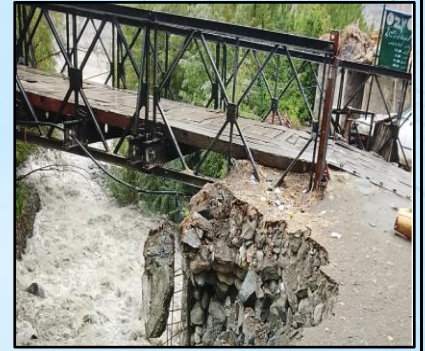
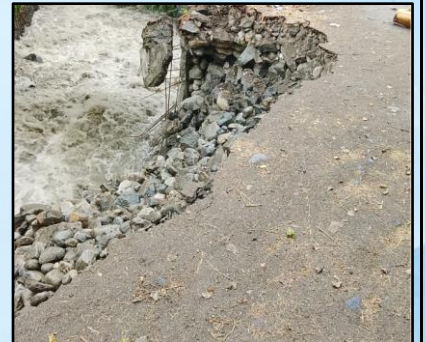
**ASSESSMENT STATUS:** HIGH RISK OF FAILURE

Install Stepped Gabion Protection. Stepped gabion protection should be provided at vulnerable riverbank and bridge approach sections to control erosion, dissipate flow energy and protect against progressive scour.

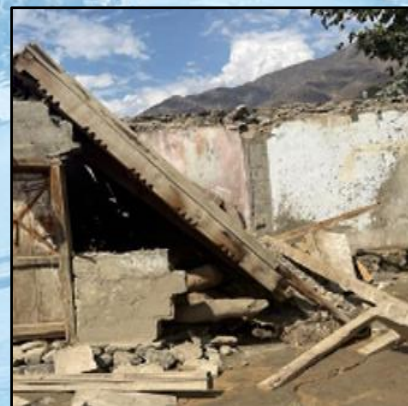
**ASSESSMENT STATUS:** PARTIALLY–FULLY DAMAGED

RCC flood-protection walls and increased channel wall height can improve flood containment and reduce the likelihood of overtopping and direct inundation of nearby houses.

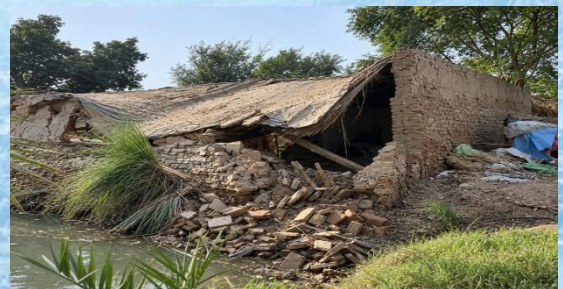
The combined influence of poor drainage, soil instability, and waterlogging triggered widespread foundation failures. Structural inspections revealed prominent wall cracks, floor settlement, and in some instances, complete structural failure due to compromised load-bearing capacity. Areas affected by prolonged submersion or recurring seepage showed accelerated structural degradation.

*Figure 19: Foundation failure and severe structural cracking caused by prolonged waterlogging and soil instability.*
